OFFICE OF SURFACE MINING

***Evaluation for Targe Energy dba Coal Valley, LLC
SMA Permit No. O-2005-10, NPDES WV1023721, and UIC 0284-00-033***

April 21, 2011

Harrison County, West Virginia

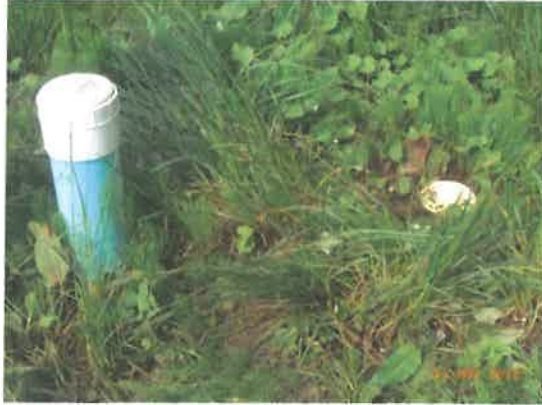
Figure 3. Injection borehole UIC 201 prior to redesign by Coal Valley, LLC.

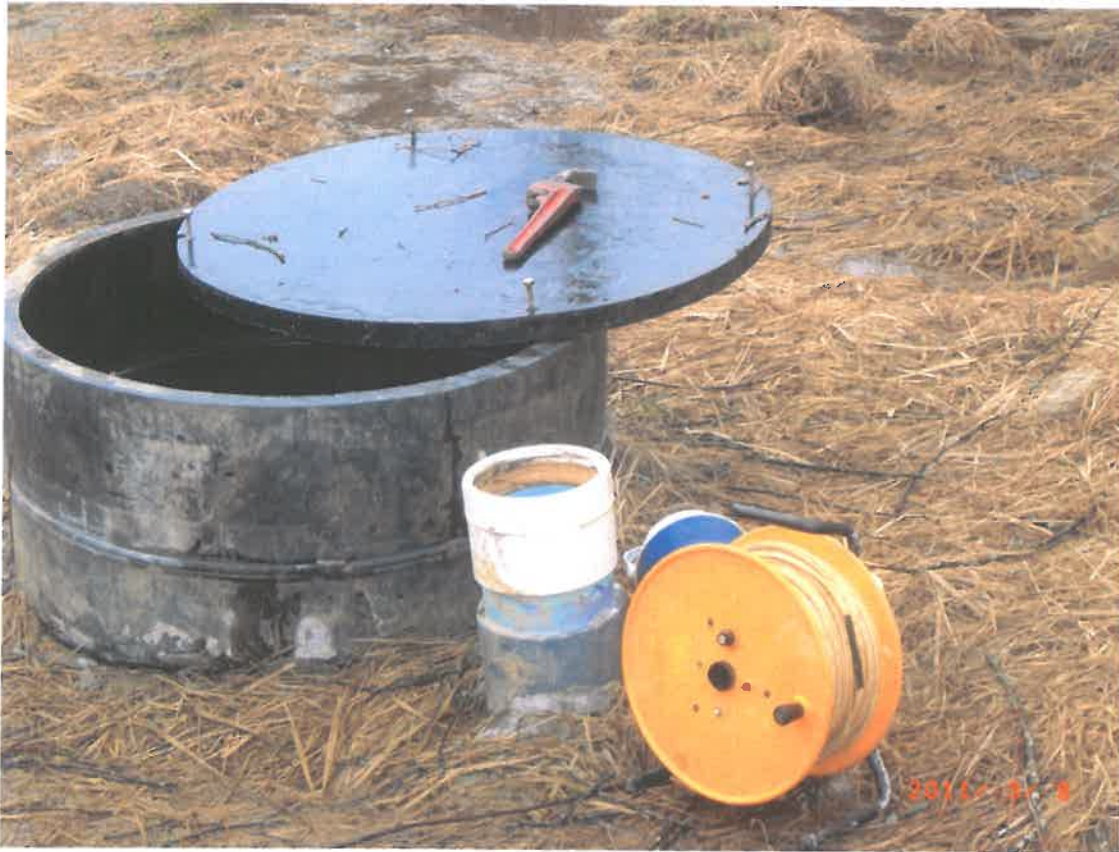
Figure 4. Injection hole UIC 201 redesigned in 2011 to avert surface runoff entering the borehole by Coal Valley, LLC.

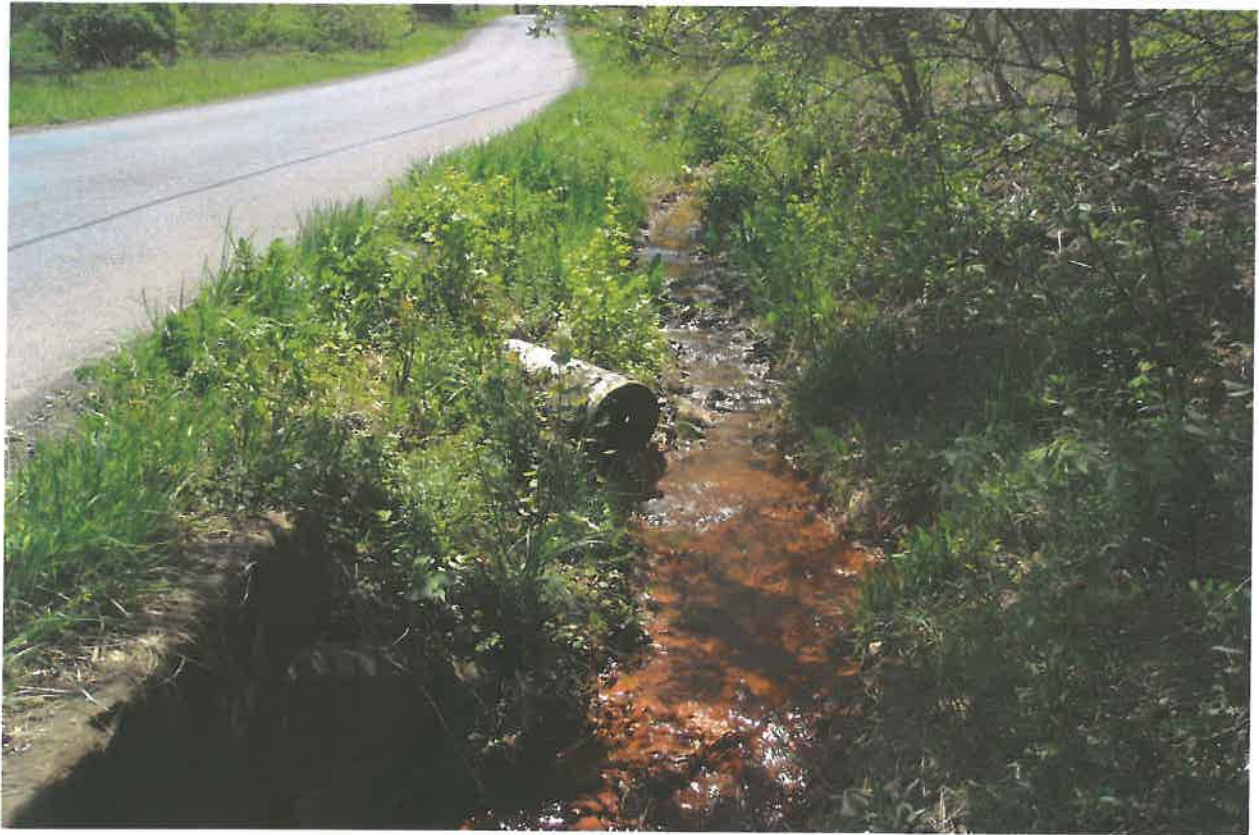
It was determined in the field review that the M & J mine is in fact not restricted and upwells to the surface as well as discharges into Bingamon Creek by entering an inverted drop inlet, (elevation 913.46) that crosses under County Route 8 and discharges through an existing inverted

concrete "Bell Pipe" at an elevation of 909.10 ft. This condition is causing the stream to be stained as a result of precipitates. Water samples were collected by WVDEP from the discharge to Bingamon Creek on March 8, 2011, and results are pending (Figure 7, 8, and 9).

Figure 8. Existing headwall of culvert that drains to Bingamon Creek.

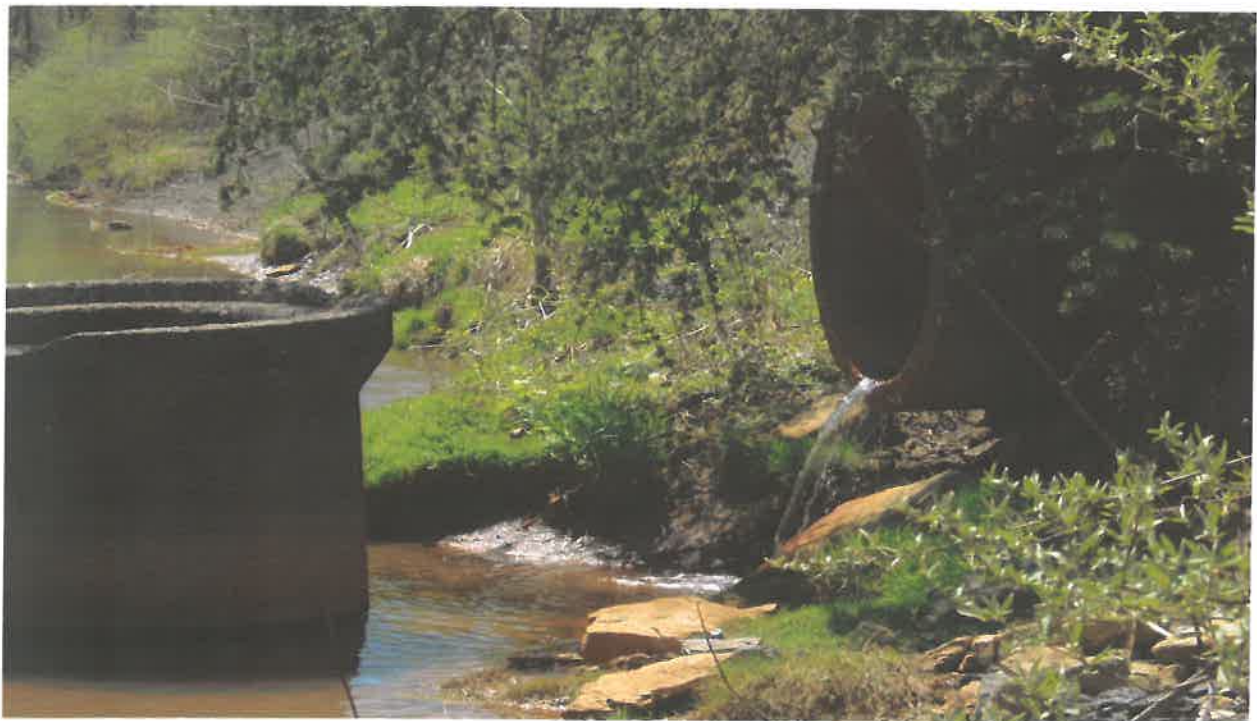
Figure 9. Existing concrete bell pipe discharging into Bingamon Creek.

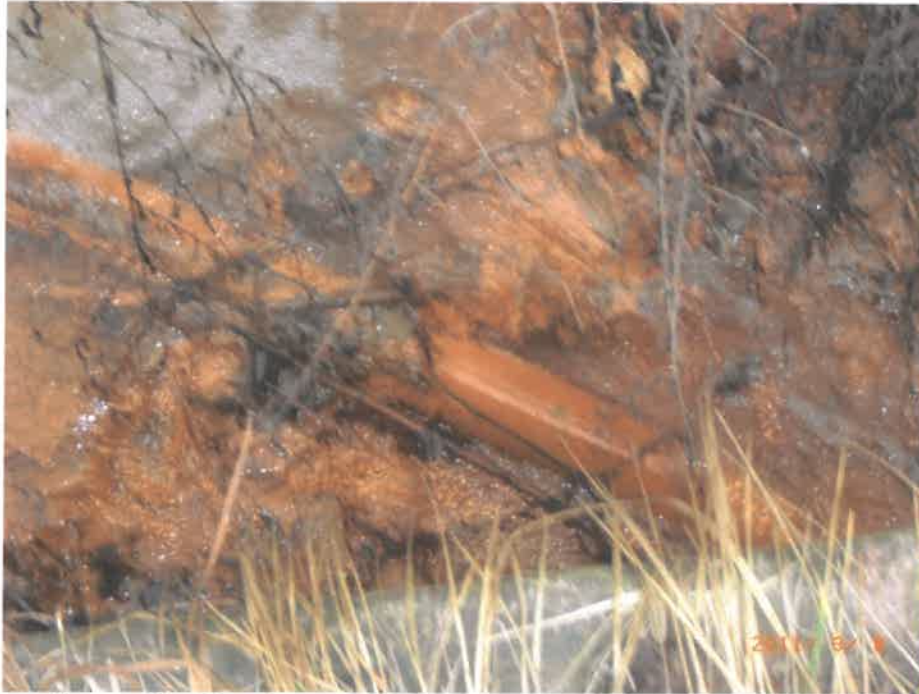
It is unclear if the pipe that is shown in the stream and placed within the culvert that is adjacent to UIC 201 injection point that discharges to Bingamon Creek is part of the Coal Valley, LLC discharge design since the pipe was not present during the May 2010 field assessment (Figures 10 and 11).

Figure 10. Pipe in stream adjacent to UIC 201 injection point.

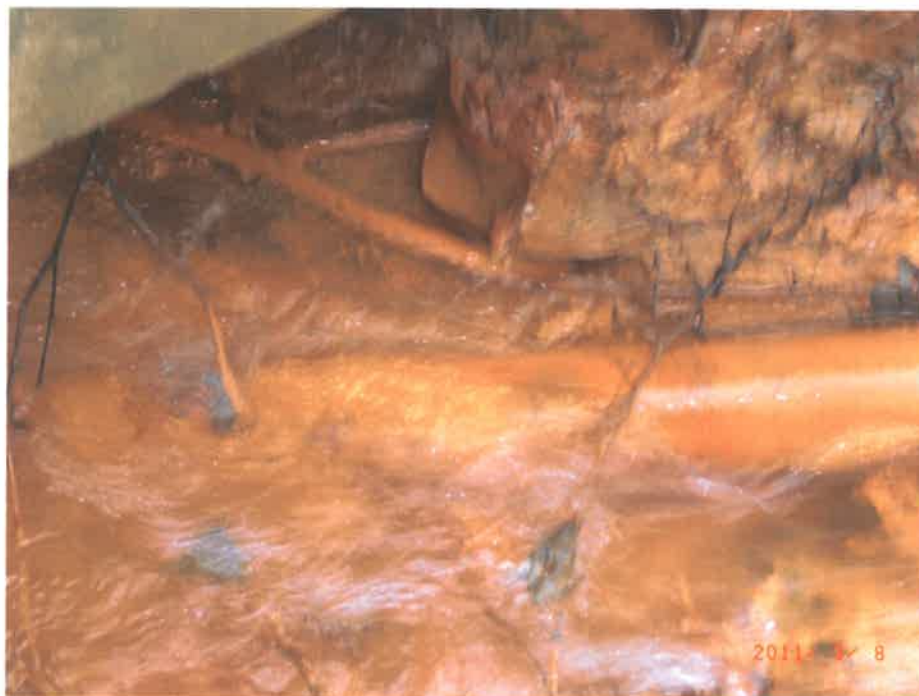
Figure 11. Pipe within culvert discharging to Bingamon Creek.

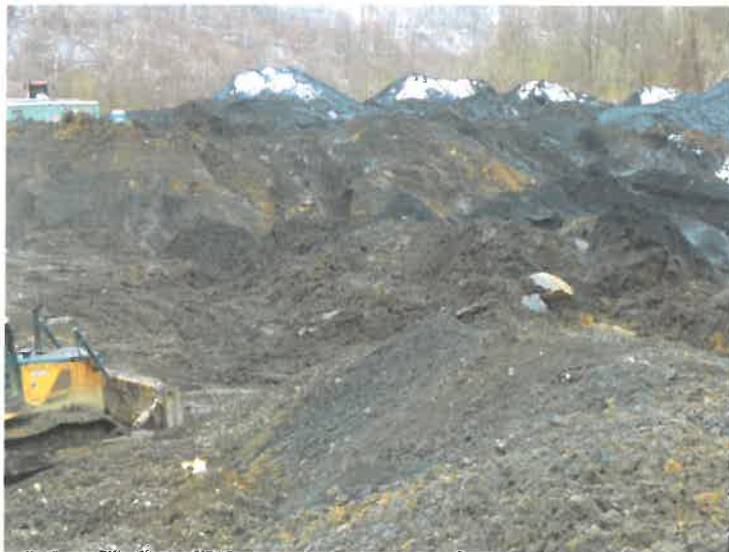
We began the above ground review of the site by traveling up County Road 8/6, Nutter Run, and we immediately noted that the mine haul road to the left abutment of the impoundment was very steep, lacked proper drainage and protective surfacing, and directed drainage directly onto County Road 8/6.

Upper end of haul road that connects directly to county road.

Failed to conduct operations only as described in the approved application in that the haulroad is not constructed at the approved location in the permit and properly certified.

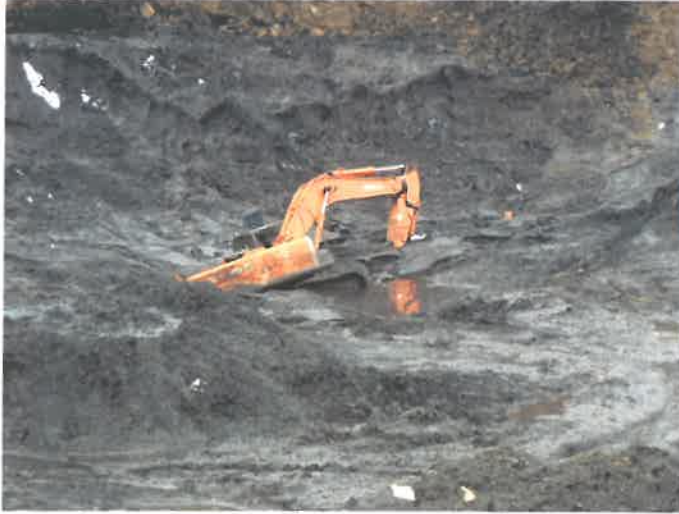
We then viewed the active mine pit area and discovered that a backhoe was almost fully engulfed in the bottom of the saturated slurry pit.

Close up of backhoe engulfed in slurry pit.

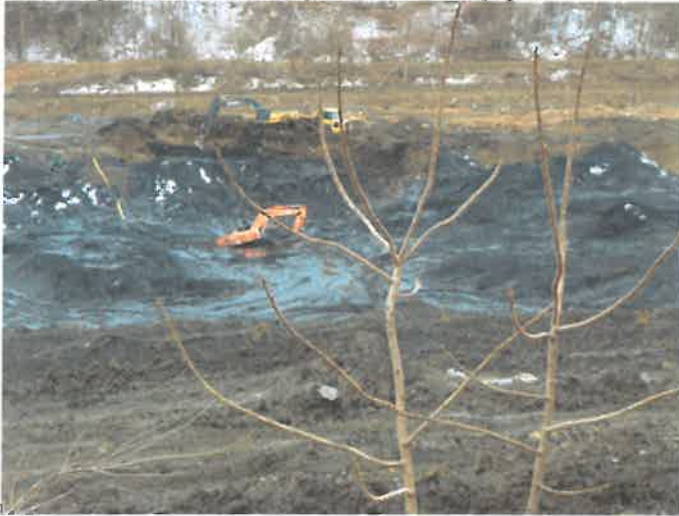
Overall view of slurry pit with excavator removing soil and rock cap from the slurry surface.

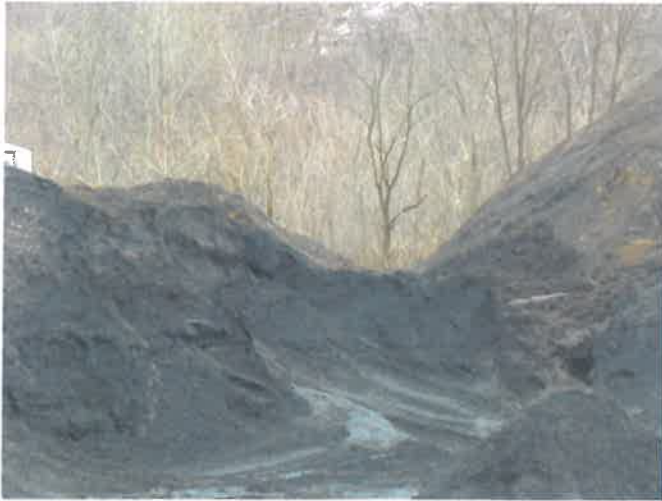
We then noted an area of the slurry pit where part of the original impoundment embankment had been excavated to an elevation lower than the original crest. WVDEP Inspector, Mike Nunan, noted that two different sections of the permit, P-7 Narrative and N-1, require emergency spillway construction in conjunction with mining activities to limit the volume of the excavated mine pit to 15 acre feet. The same sections require certification by a registered professional engineer that the structure is constructed in accordance with the permit, the Act, and the regulations. WV CSR 38-2-5.4.b.9 requires that all sediment control or other water retention structures shall be designed to safely pass a 25 year 24 hour precipitation event. A single open channel spillway may be used only if it is of non-erodible construction and designed to carry sustained flows. WVDEP has not issued a violation requiring the permittee to construct and certify that the emergency spillway and mine pit are in compliance with both the permit and regulations. Some of the spillway construction has occurred, but it is neither complete nor certified.

Looking into partially constructed spillway-not certified.

Failed to certify the emergency spillway which is designed to drain the allowed impounding volume of 15 acre-feet or less, as specified in Section P-7 of the approved permit.

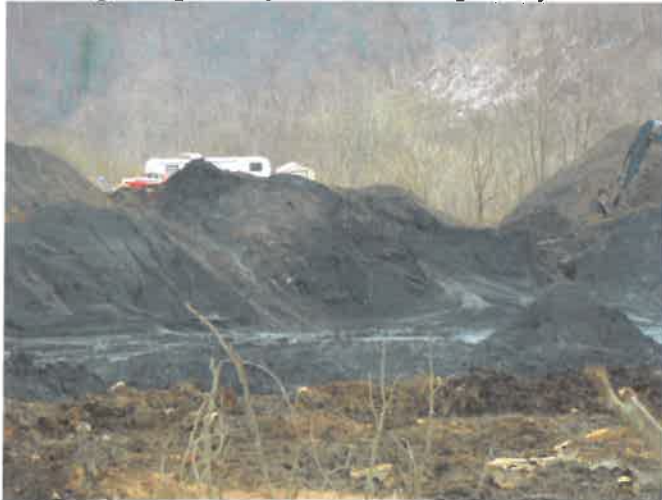
Additional view of emergency spillway to maintain pit below 15 acre-feet.

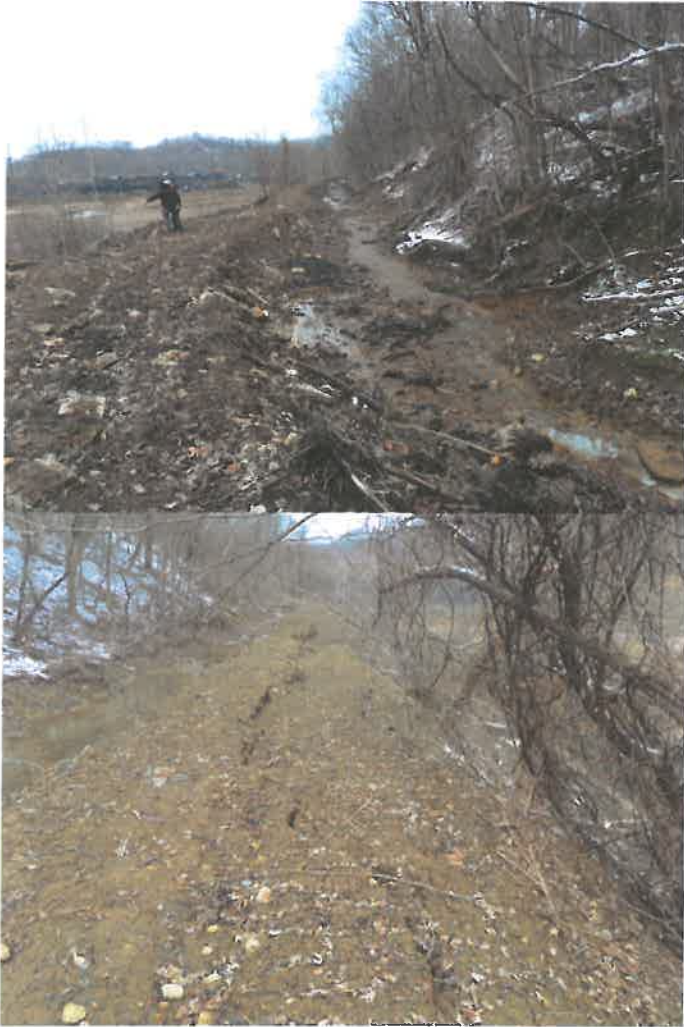
We then proceeded to the right abutment of the upper impoundment's embankment where the stream diversion is routed across County Road 8/6. We walked down the diversion channel and noted that conditions had changed from April, 2010. The diversion channel has been disturbed and reconstructed.

Reconstructed channel showing flow at left and recent embankment construction.
The area of disturbance is not within the boundaries of the approved permit and it is not bonded.
It is considered disturbance outside the permit boundary.

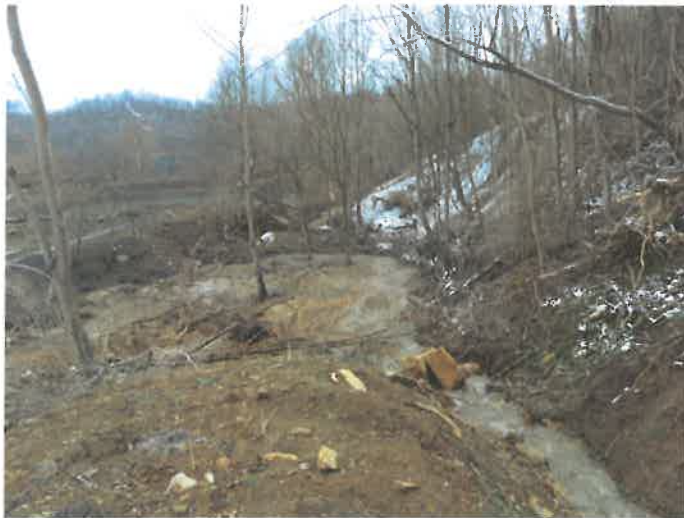
At this point near the right abutment of the lower slurry impoundment, the diversion channel is directed into the channel formed by the old emergency spillway for the original lower impoundment. The flow follows the old emergency spillway channel and then junctions with the original diversion channel on the steep hillside directly above County Route 8, a heavily traveled paved road. The flow then passed thru a drop inlet into a 6 foot diameter pipe and on into Bingamon Creek. Concrete channel lining placed on the steep hillside by Consolidation Coal Company has been undermined by water, collapsed and slid down the hill (see the following 3 photos).

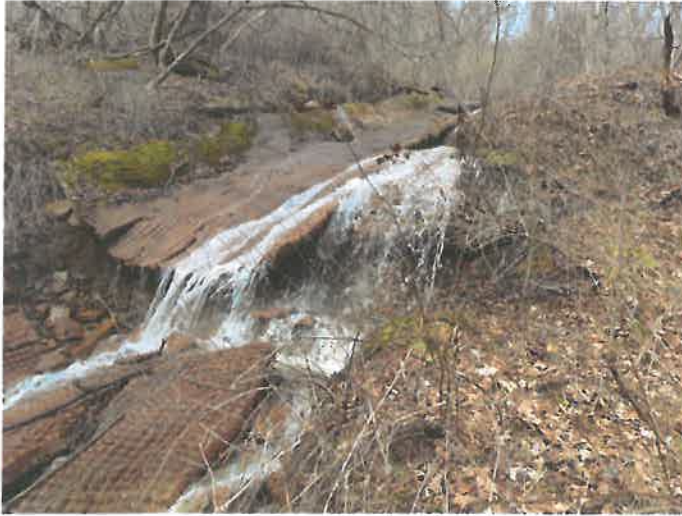
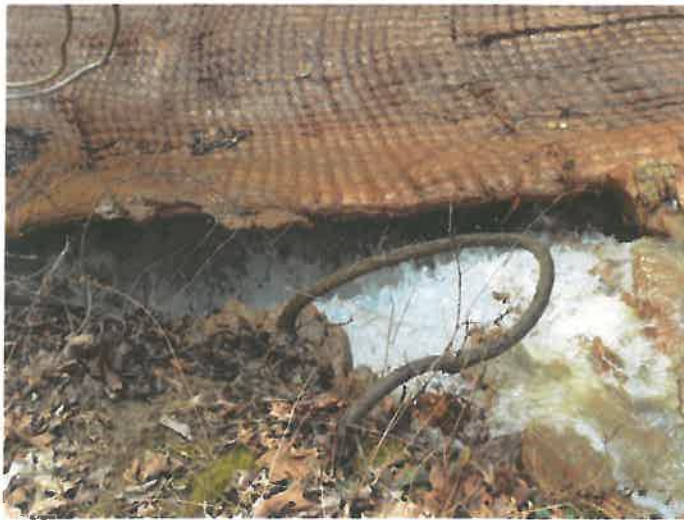
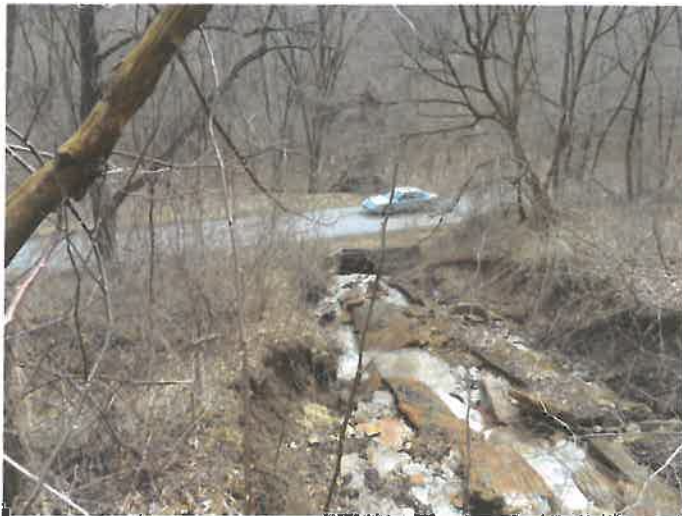
Photos of failed channel liner in diversion channel above County Route 8.

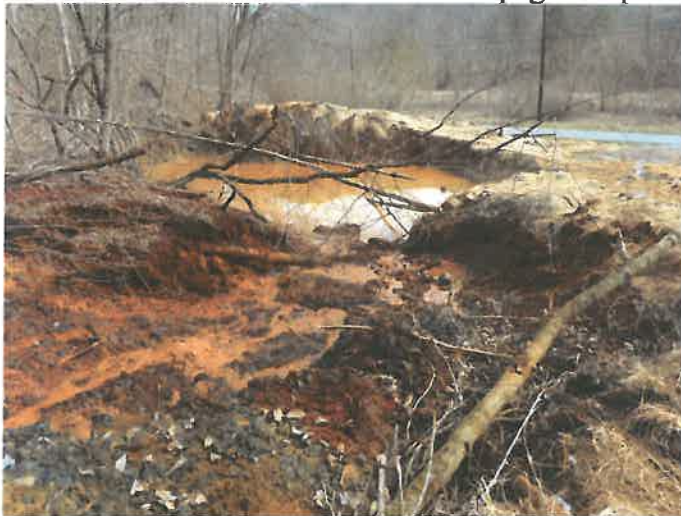
We then went back to the lower borehole located at the old impoundment toe seepage area. This area has been disturbed and the old seepage sump has been enlarged.

Pond enlarged and disturbed. This is not shown on the permit.

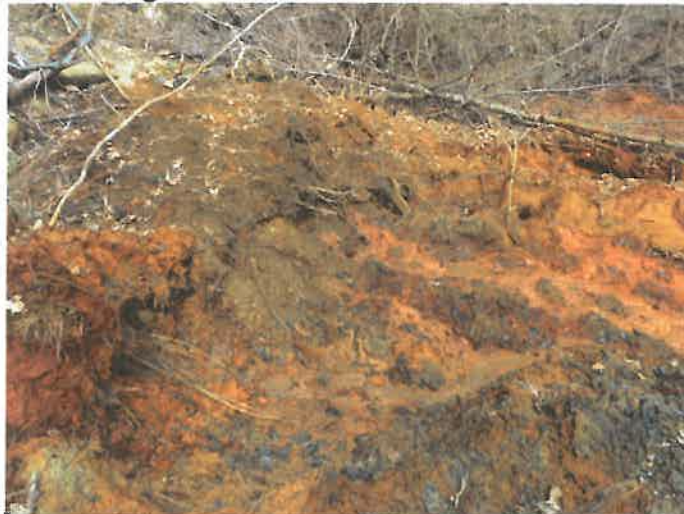
Seepage above pond through old embankment.

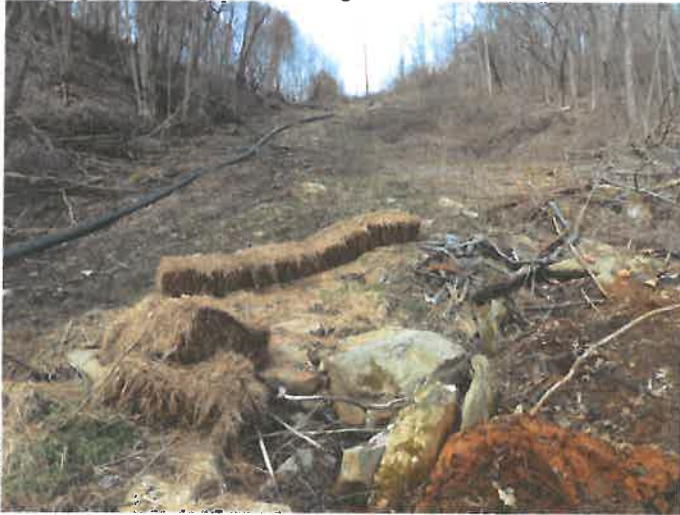
Looking up old embankment from AMD pond. Black 6 inch pump line is shown on right. The approved plan authorizes the pumped flow from 3 small treatment ponds for runoff from the 36 acre disturbed area to be directed down this 6 inch diameter conduit into the 6 inch borehole that is full of water and 32 above the approved elevation of 888. Note the gray line on the left?

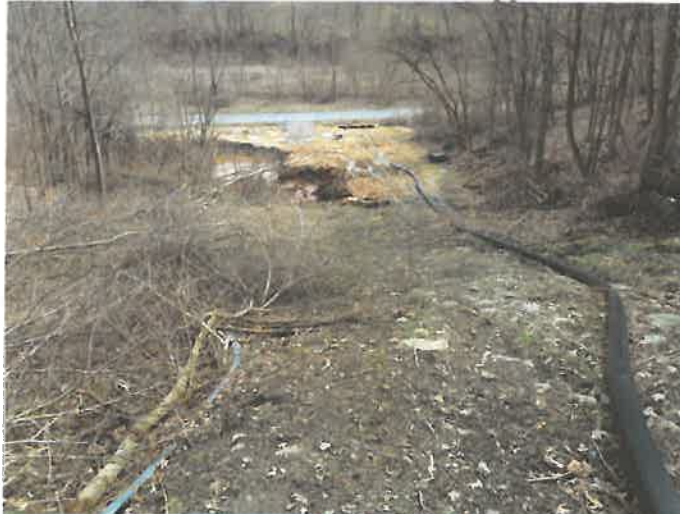
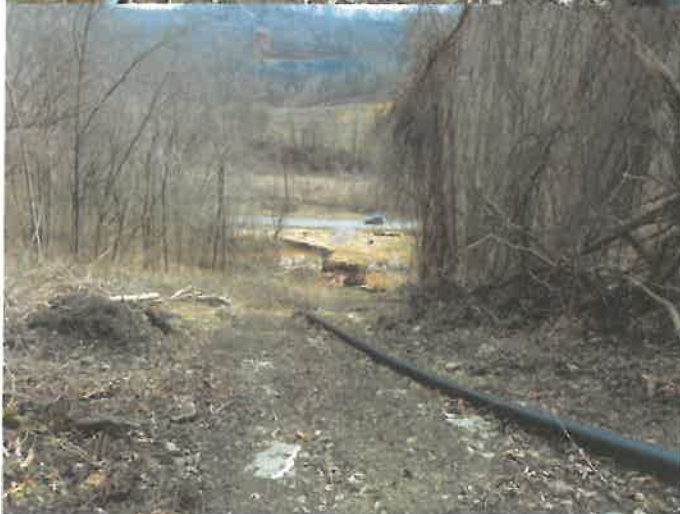
Looking down embankment face at pond and county road.

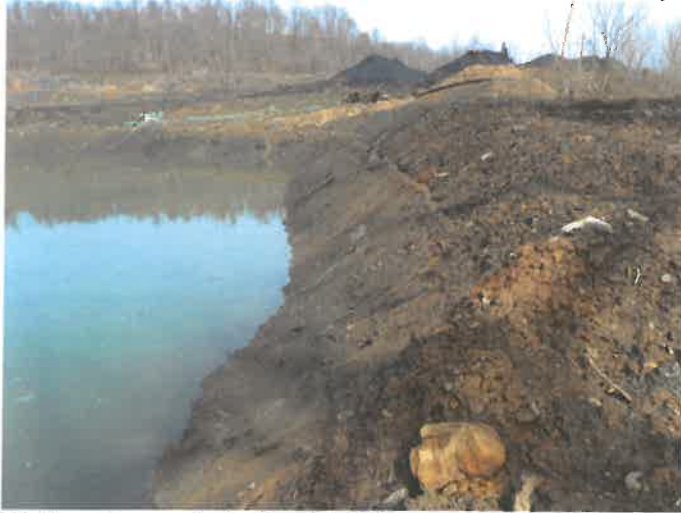
High water mark in final holding pond on old impoundment embankment.

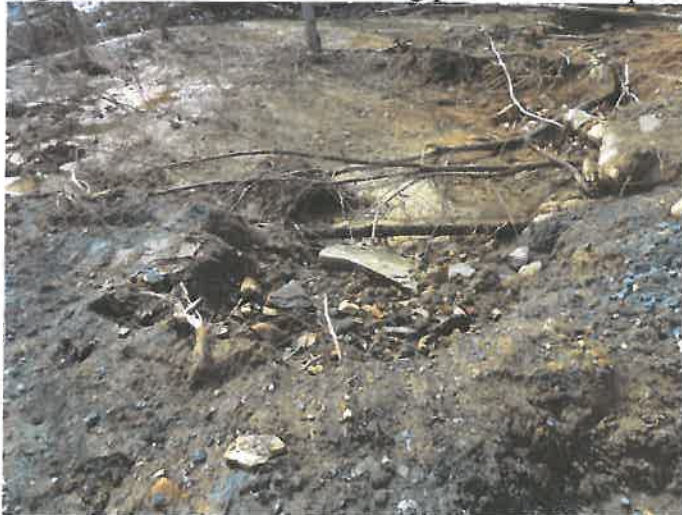
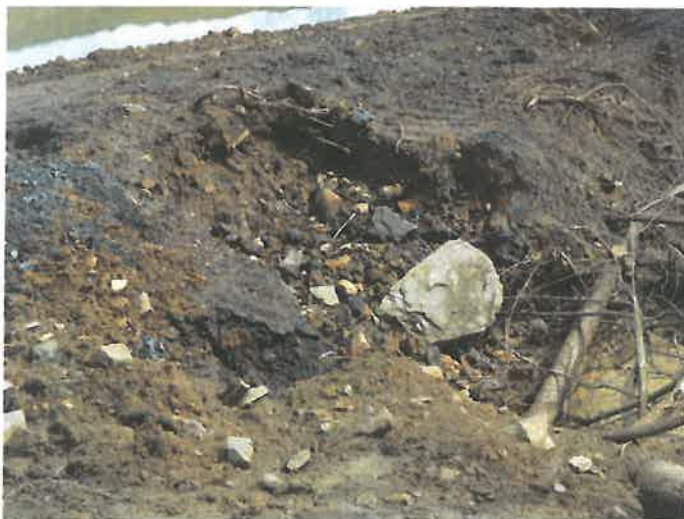
Erosion on embankment of final holding pond. Appears to be pumped/breached and unauthorized discharge from pond into fresh water diversion.

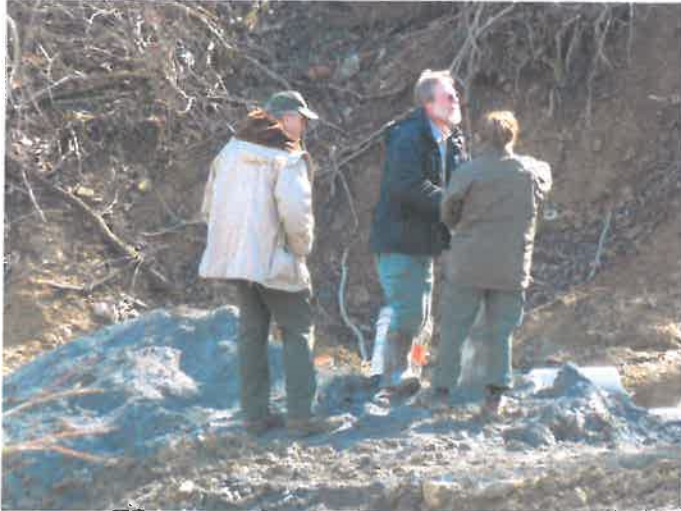
Checking water level at re-drilled borehole at upper end of lower impoundment. We then all met and discussed findings. The immediate technical assistance that we relayed to WVDEP Inspector Nunan was:

1. The construction work on the stream diversion is mining off of the permit.
2. Emergency spillway must be certified to safely pass the 25 year -24 hour precipitation event, and the operator must demonstrate that the total potential impounded volume is 15 acre feet or less.
3. Haul road must be constructed and certified in accordance with regulations.
4. No drainage can leave the site.
