**EXPERT REPORT OF ROBERT MAYBERRY**

I am the owner of RPM Home Inspect, LLC, located in Fairfax, Virginia. On March 29, 2017, I was engaged by McDermott Will & Emery LLP, in conjunction with its representation of the Defendants in the above-captioned case, to provide analyses and expert opinions regarding the structural conditions of the Property at 3510 Garfield Street, N.W., Washington, DC 20007.

I was asked to conduct a home inspection of the Property on April 1, 2017. I was asked to review the conditions of the Property that are at issue in this matter, specifically, the front porch and stairs, floors, staircases, and rear sidewalk. I was asked to present my findings and opinions in the form of an expert report.

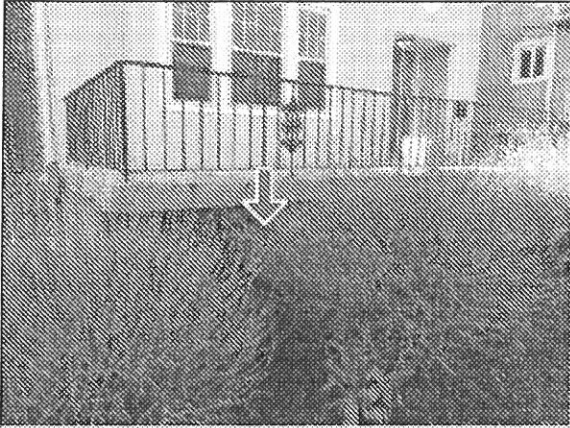
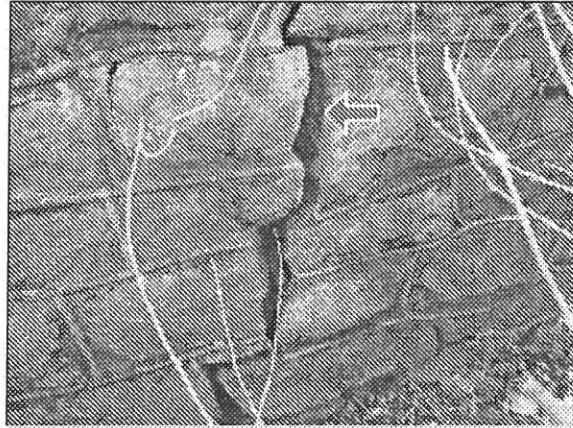
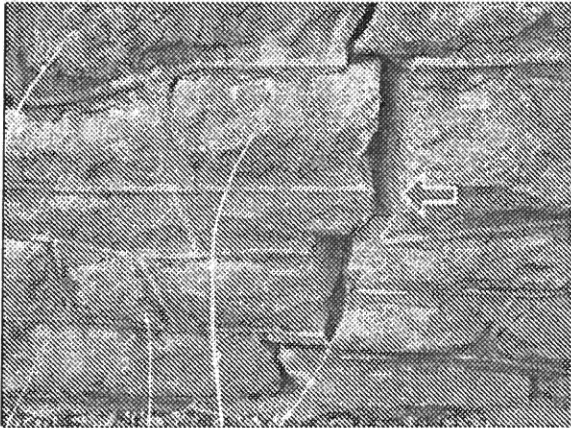
The left side of the home has settled approximately three inches, resulting in grossly uneven floors and various severe structural defects in the home. This drastic settlement is apparent throughout the home.

- There is a large crack in the structural wall under the front porch:

**Conclusion:** The drastic settlement of the home has resulted in substantial defects in the structural systems of the home. The foundation of the home should be repaired or replaced to remedy the drastic settlement before further damage occurs.

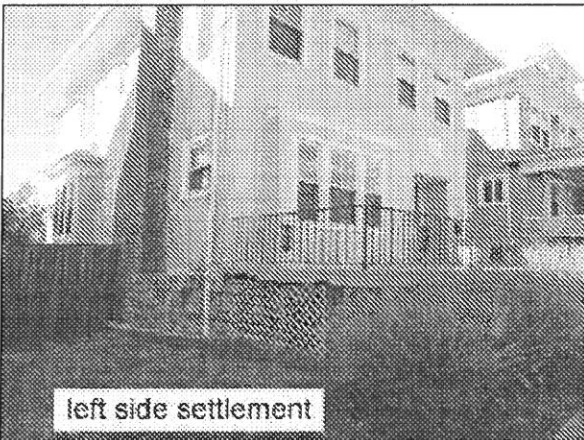
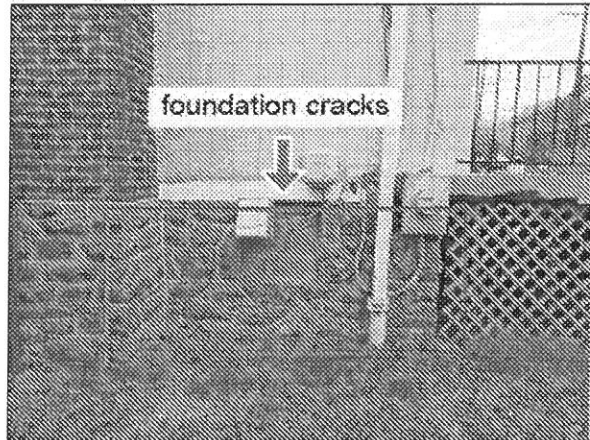
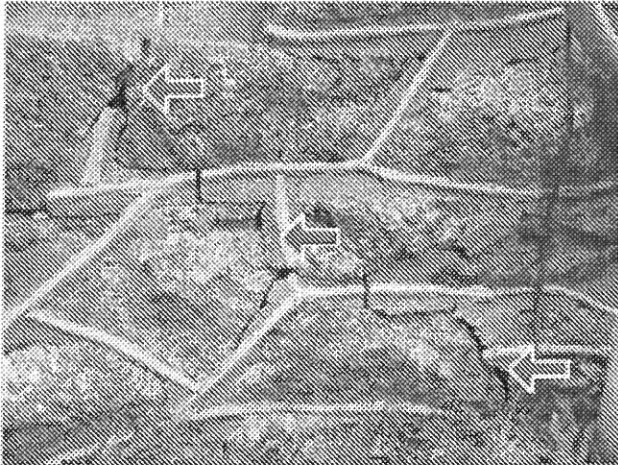
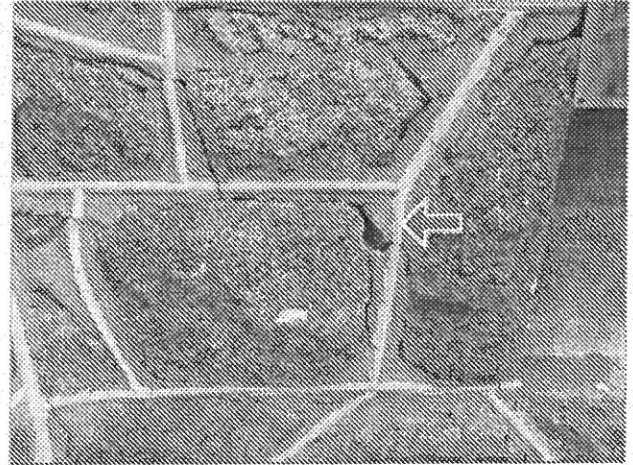
- There are also cracks in the foundation along the left side of the house:

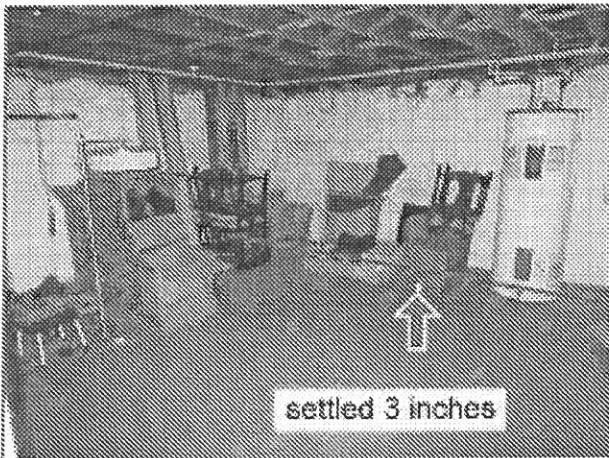
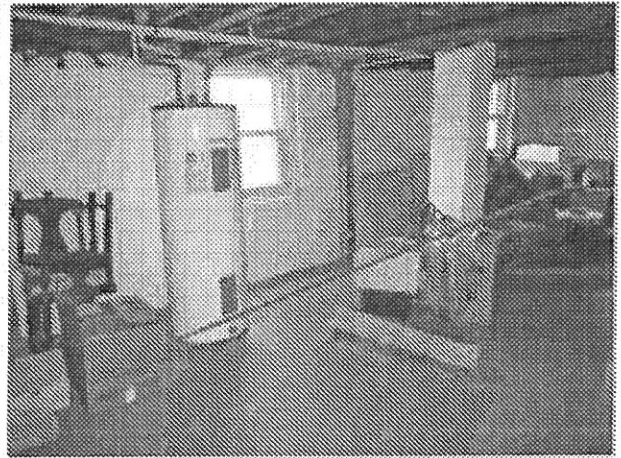
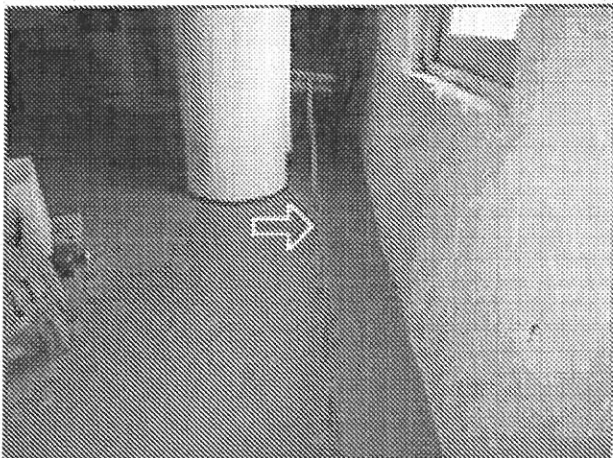
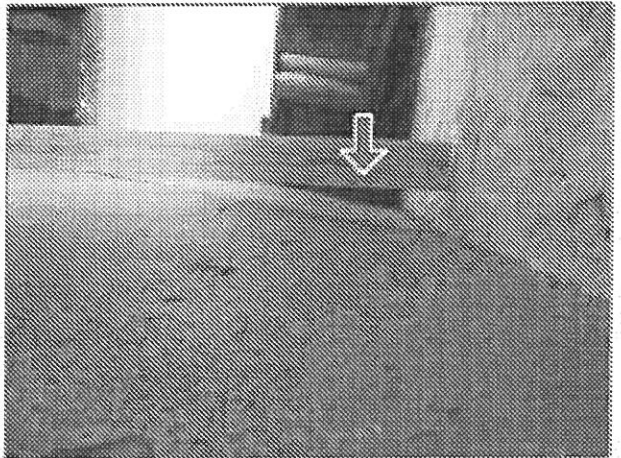
- The drastic settlement of the home is apparent in the basement:

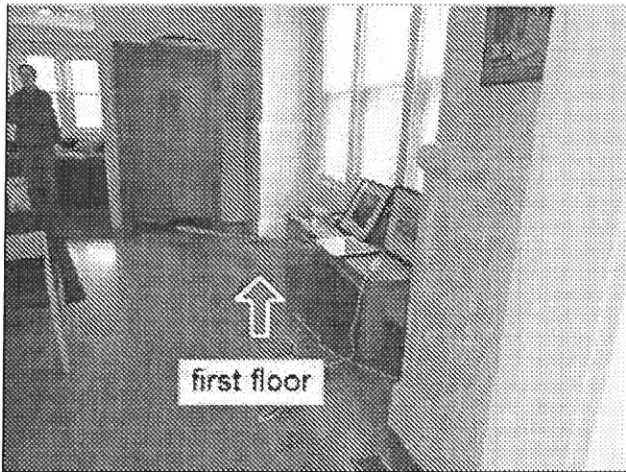
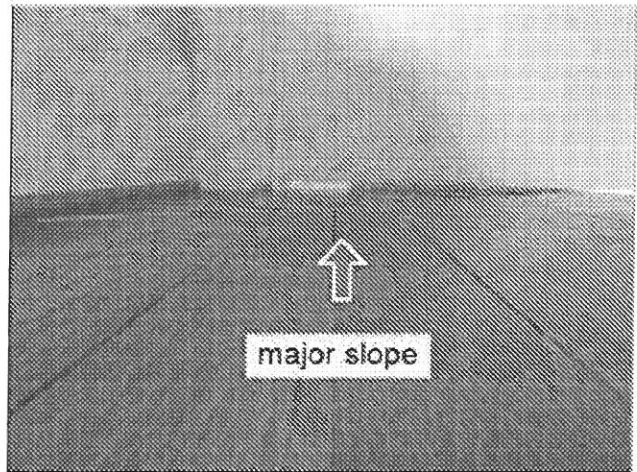
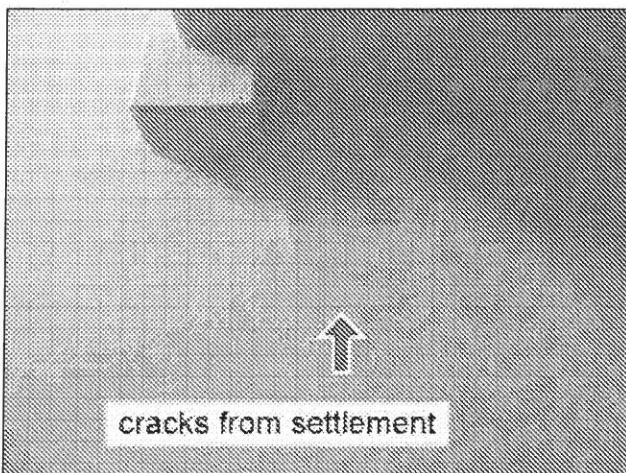
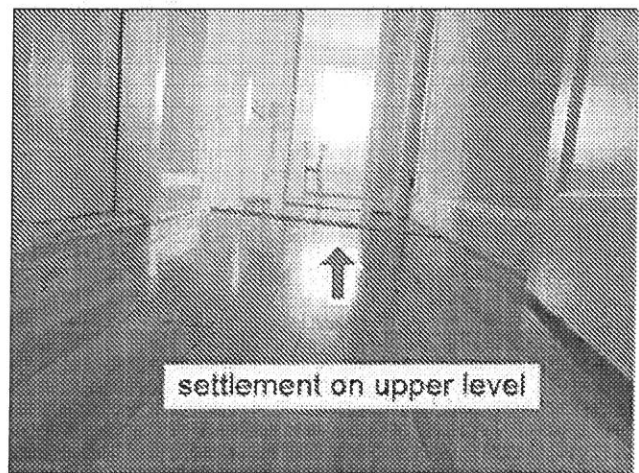
- The settlement of the home has resulted in major slopes on the main level and upper levels of the home, including cracks:

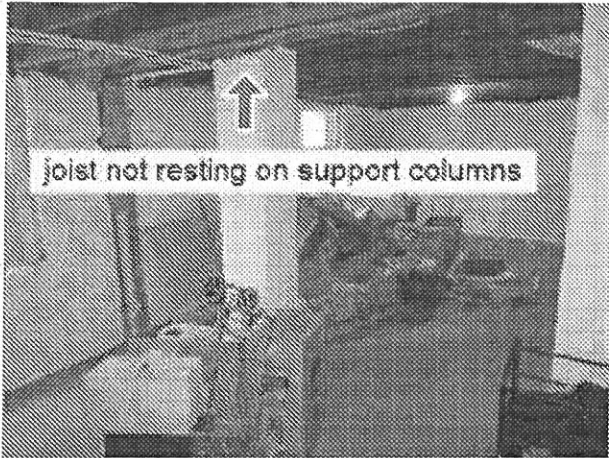
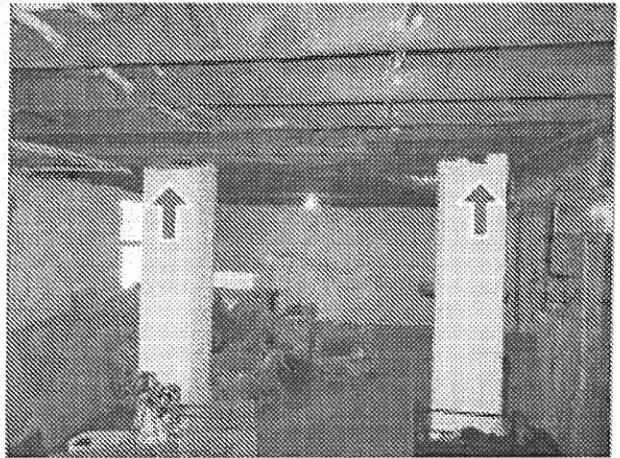
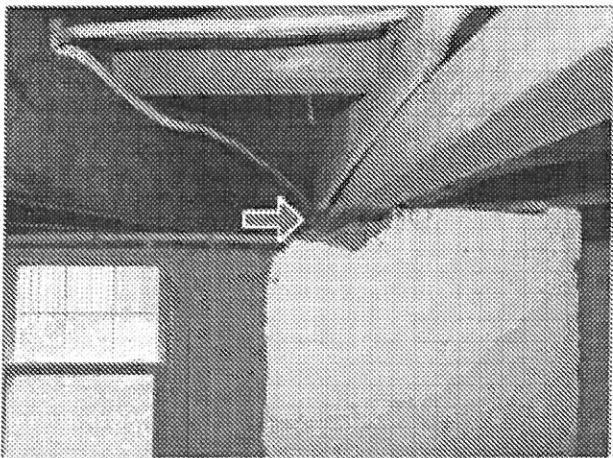
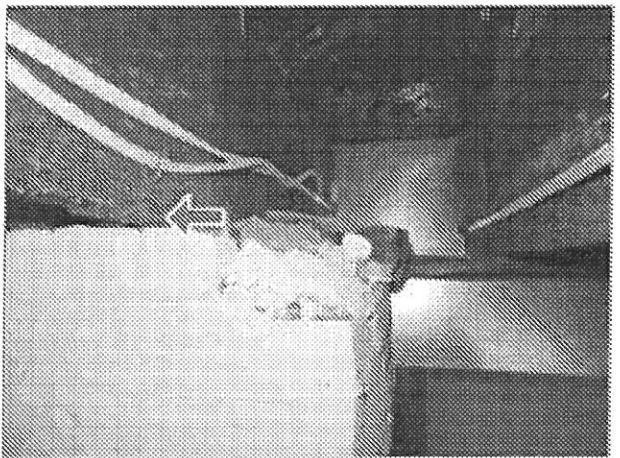
- The main center support columns in the basement that support the floors are not giving full support to the floor joist:

**Conclusion:** The flooring system has been subjected to unprofessional repair attempts. It is severely defective and requires immediate repair or replacement. These defective conditions have clearly been present for years; they have not arisen only in the past two years.

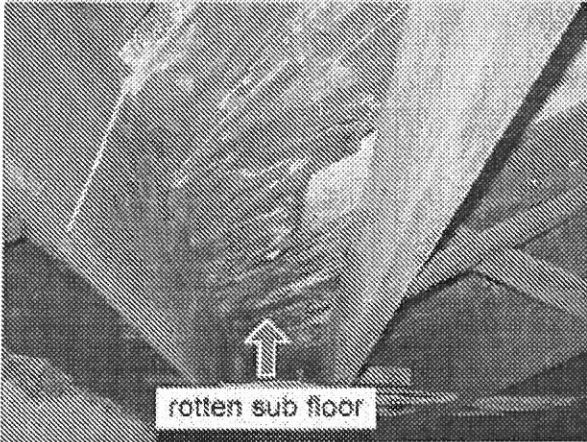
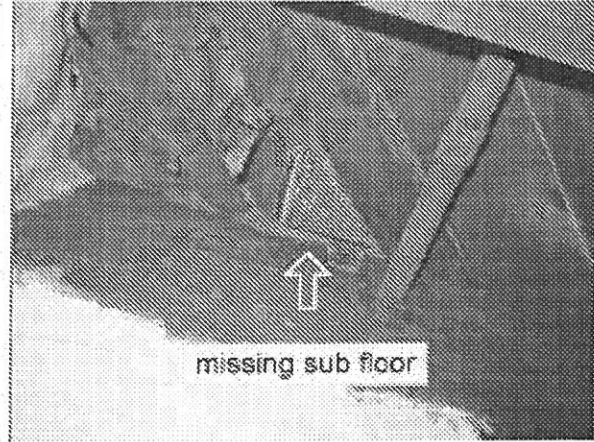
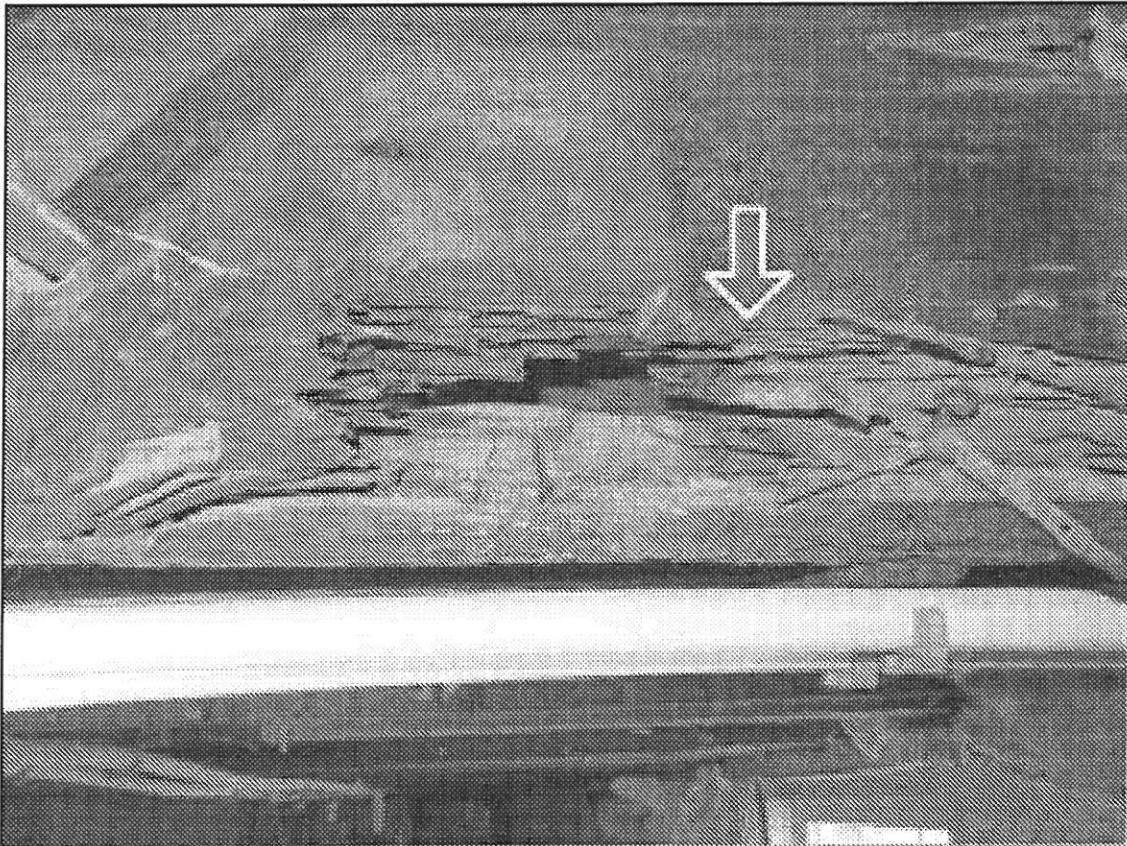
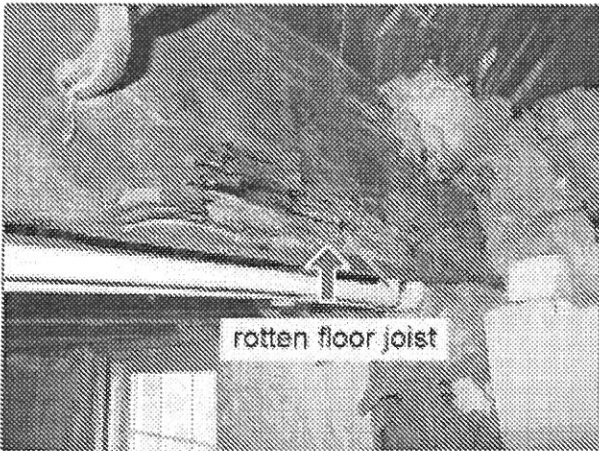
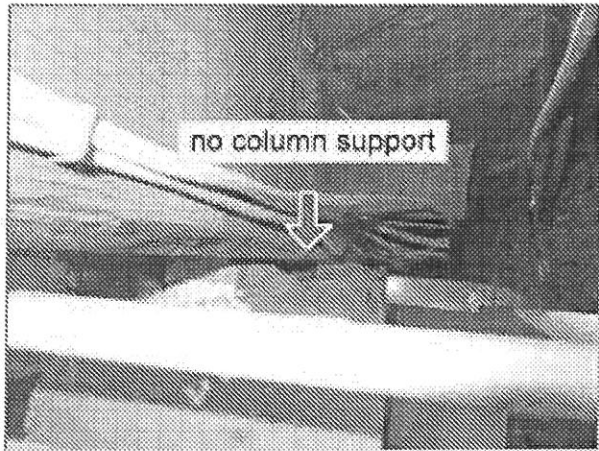
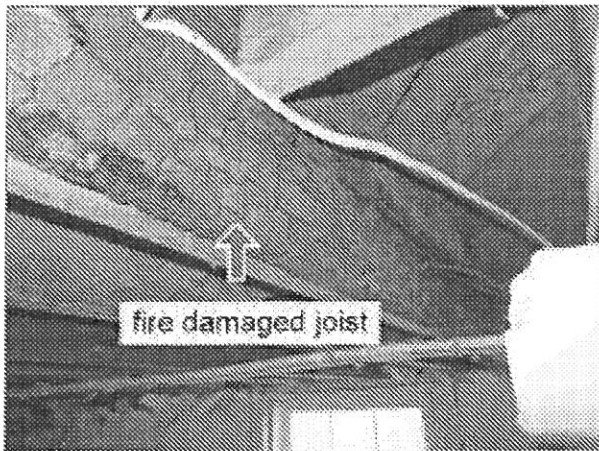
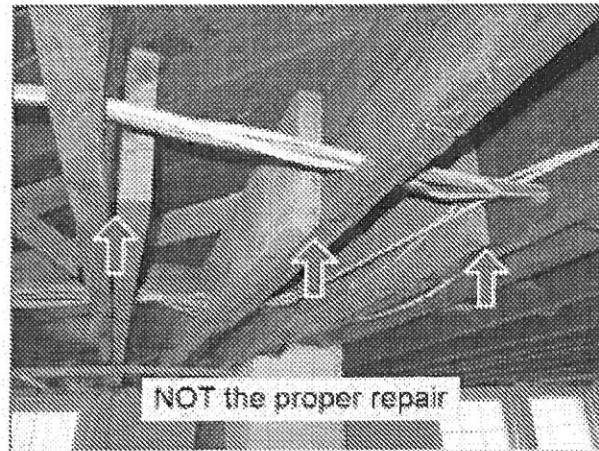
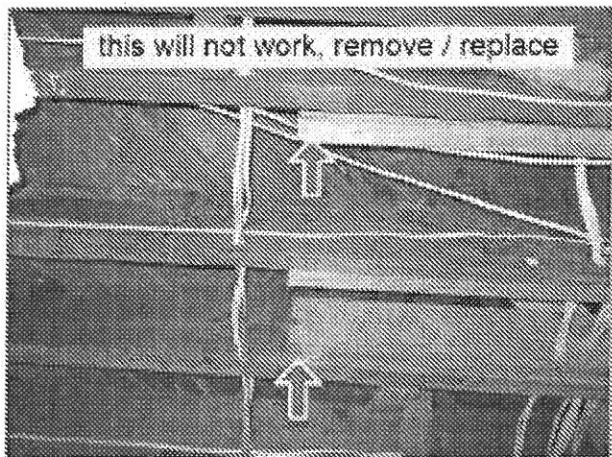
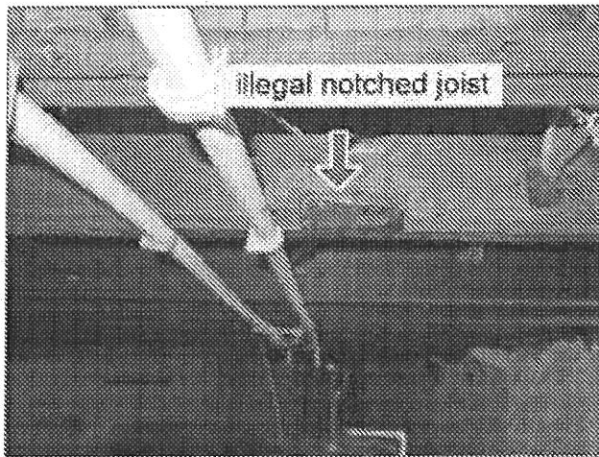
- The structural floor joist system and sub-flooring have many serious issues, which contribute to the uneven and dangerous floors on the main level. These issues appear to have been subjected to unprofessional attempts at repair, which did not fix the rotting, damaged, and deteriorating structure:

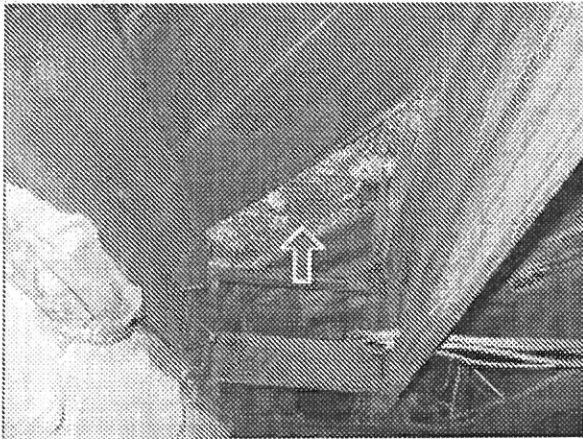
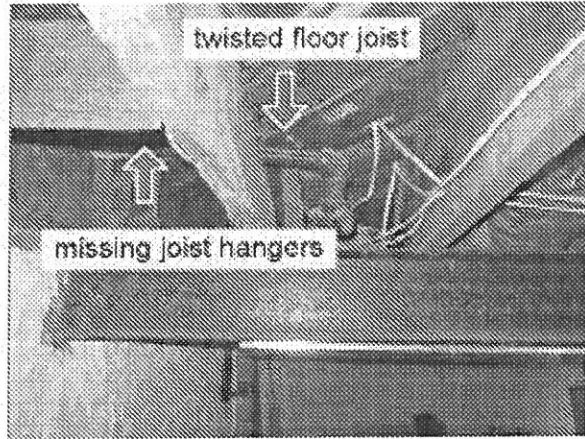
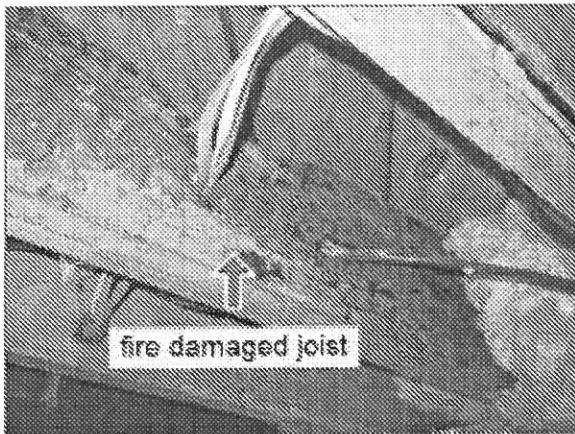
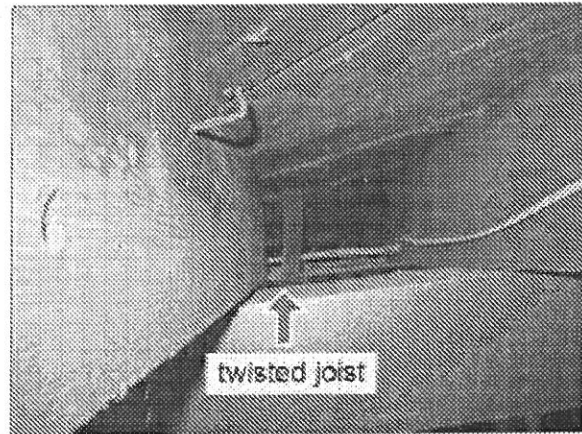
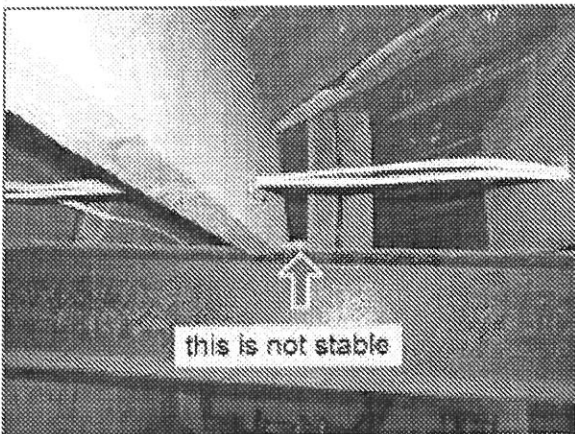
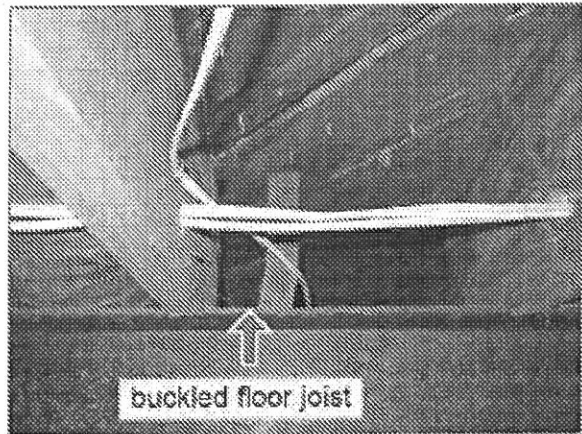
- The floor joists are twisted, buckled, unstable, and fire-damaged. There are also missing joist hangers:

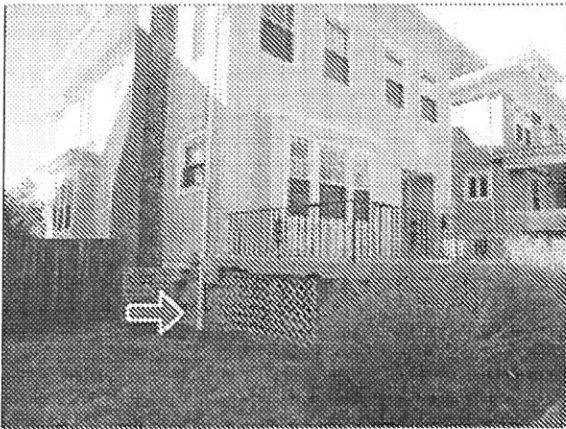
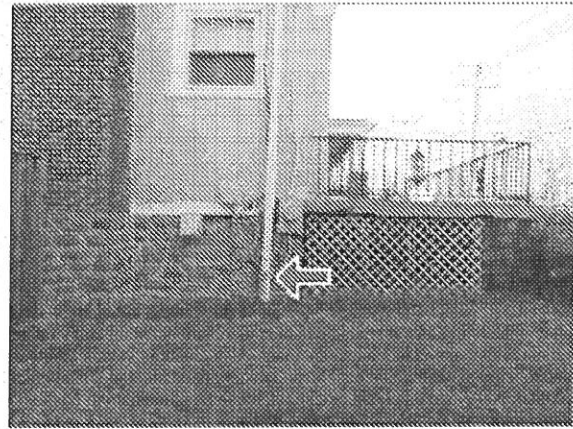
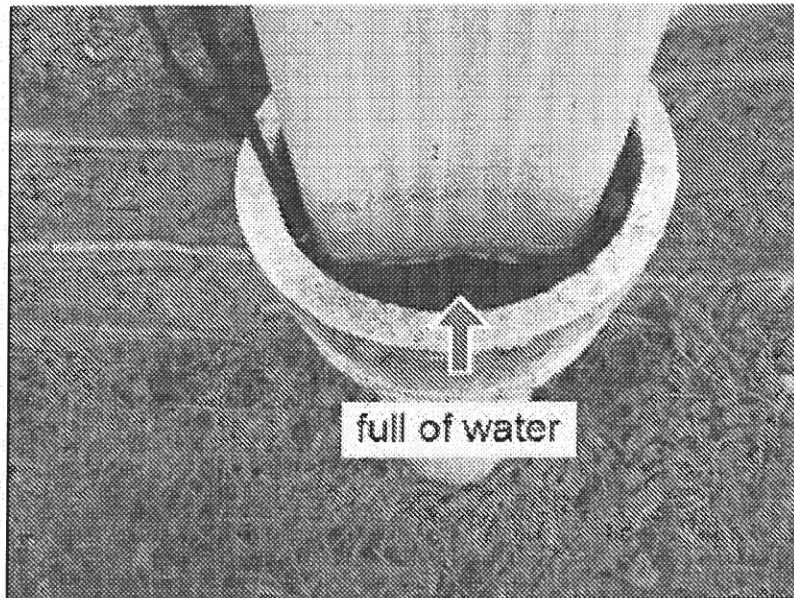
- **The downspout at the left side of the home (facing front) is clogged. Erosion has likely occurred and led to water intrusion into the home. This condition may have contributed to the settlement of the home described above in Section A.**

**Conclusion: The defective roof drainage systems have created hazardous conditions as a result of water runoff from the roofs. The systems should be repaired or replaced to avoid future injuries of persons on the Property.**

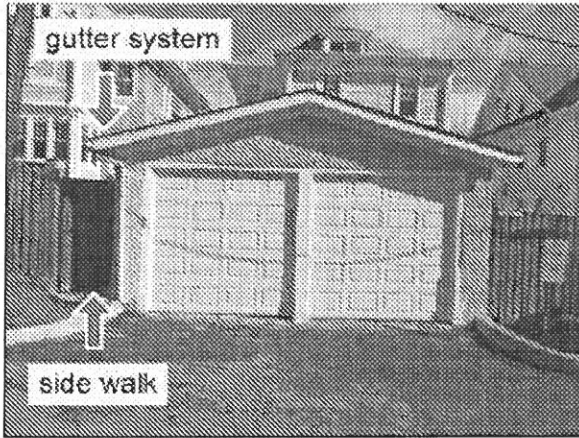
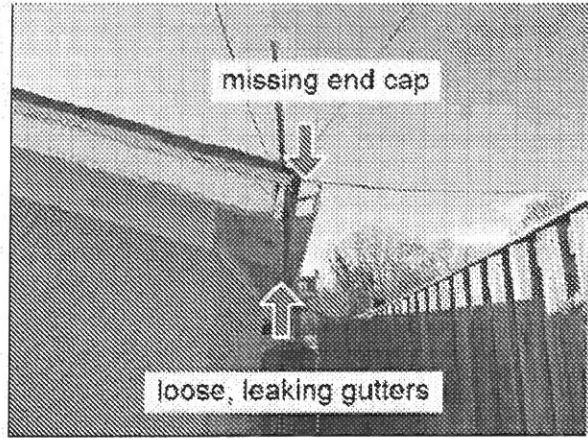
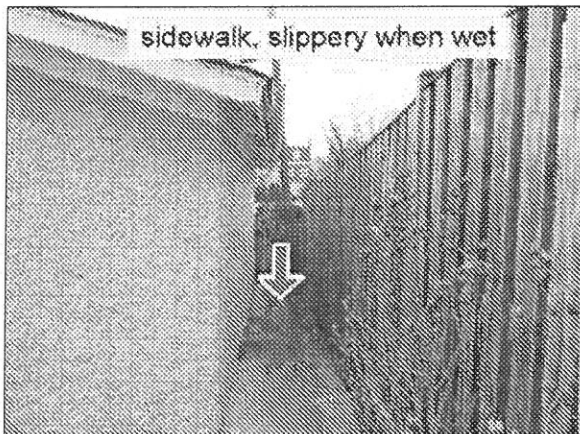
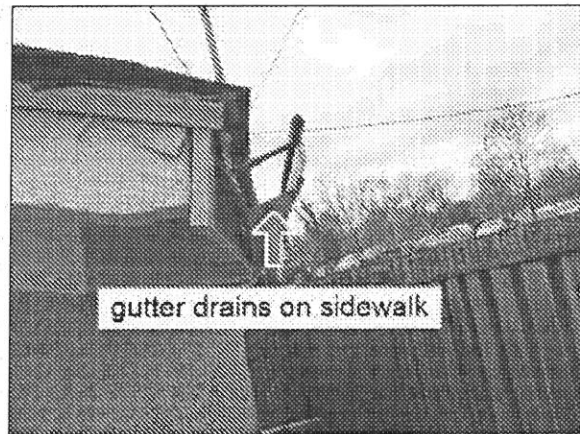
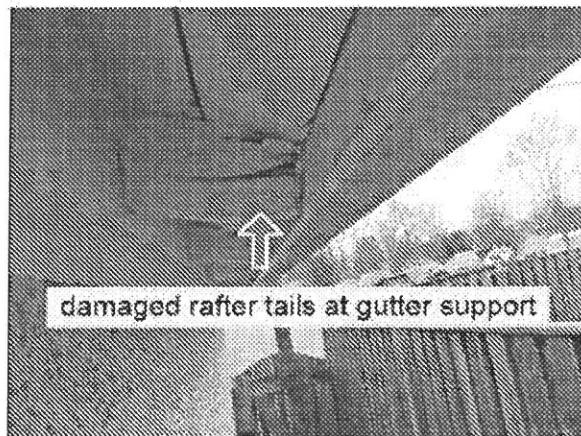
- The gutter on the detached garage is loose, has no end cap, and is draining water onto the sidewalk. This defective gutter has created a safety hazard for persons walking on the sidewalk. This condition needs to be repaired or replaced to remedy this hazardous condition.

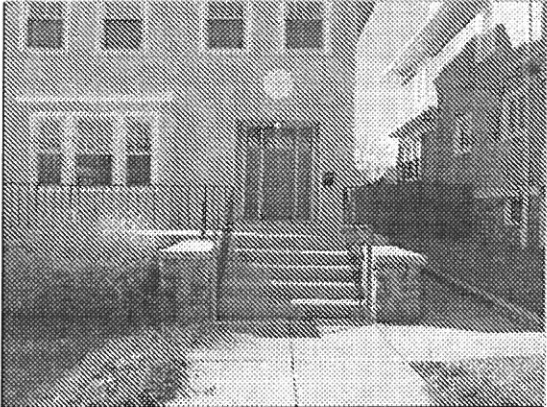
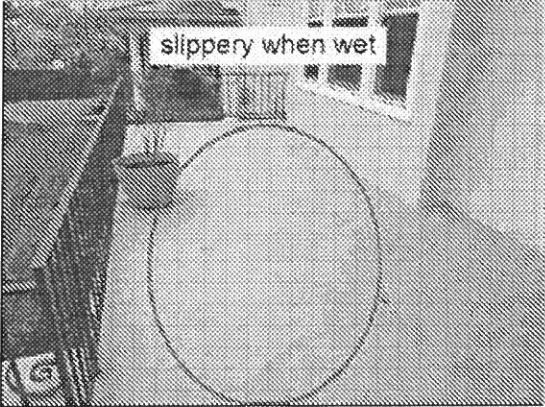
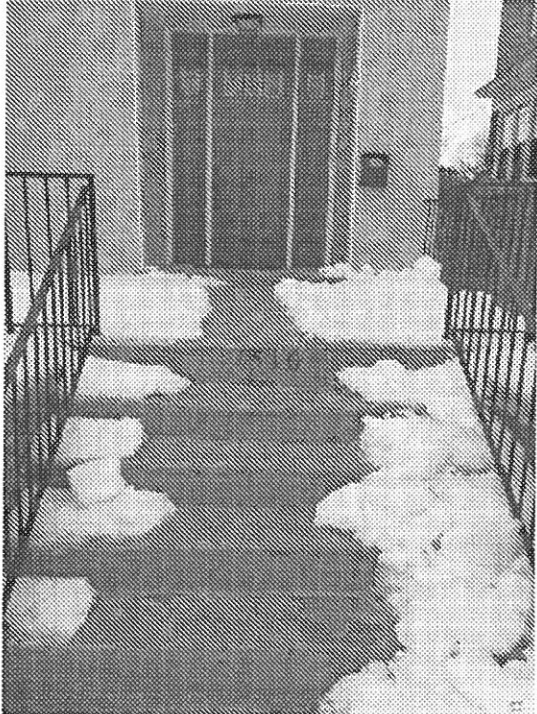
The uncovered front porch and stairs have been painted with an epoxy-like substance. It appears that some sand has been mixed into the cover in an attempt to provide traction on the surface. It is not known precisely when this occurred, but this sand still does not provide adequate traction to avoid an excessively slippery condition on the surface in the event of rain or snow.

**Conclusion:** Because of the epoxy-like substance painted on the front porch, and the lack of a cover on the front porch, any amount of snow or freezing rain is likely to result in a slick, icy surface on the front porch. The front porch and stairs should be repaired or replaced to provide persons walking on them safe surfaces on which to walk.

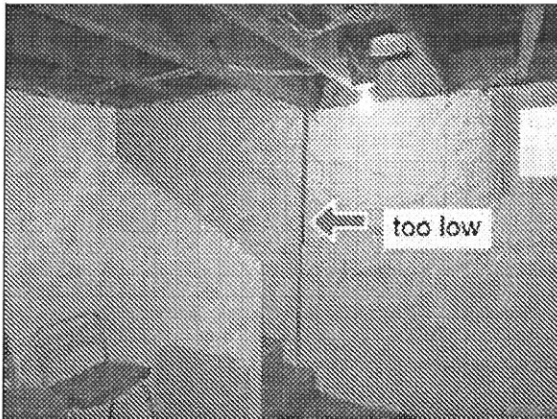
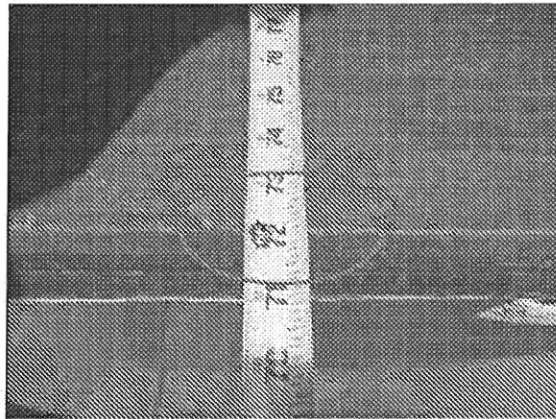
- **The head room at the basement steps is too low:**

**Conclusion:** The stairs leading to the basement are clearly defective and pose dangerous conditions for anyone that steps foot on them. The stairs need to be repaired or replaced as soon as possible to avoid future injuries.

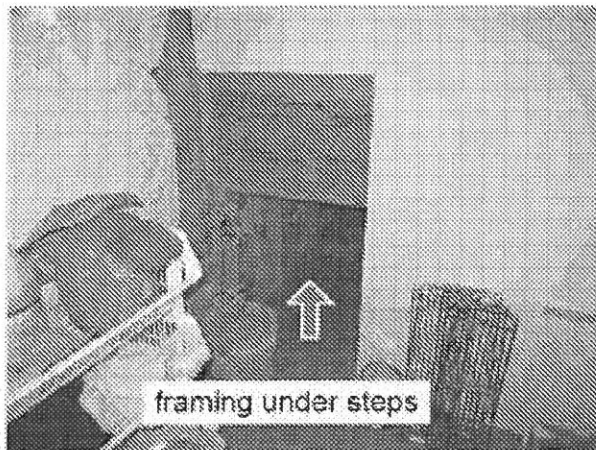
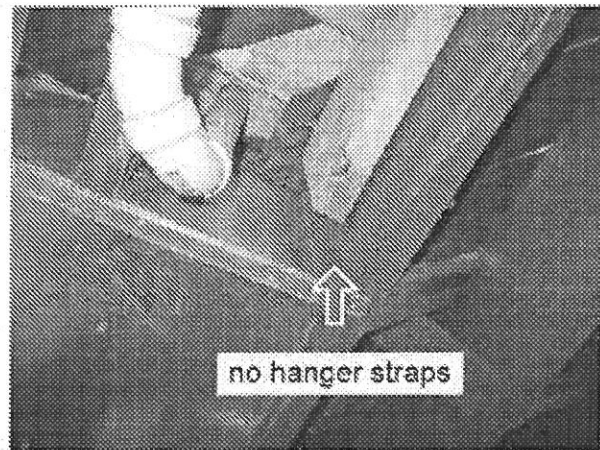
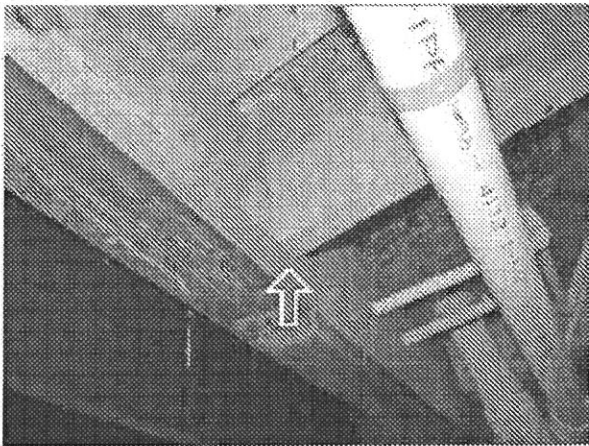
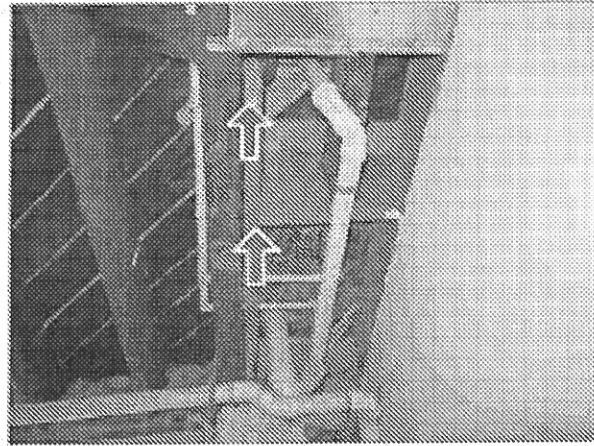
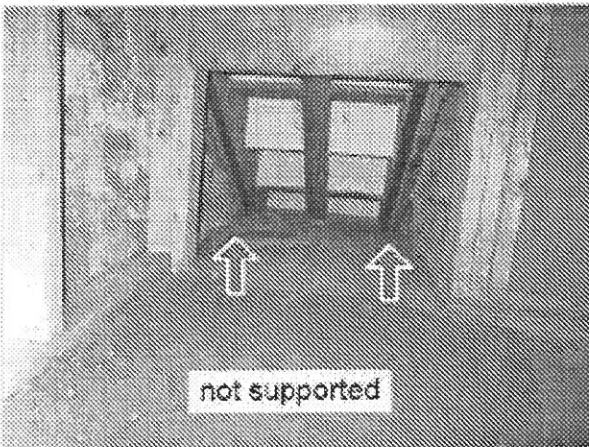
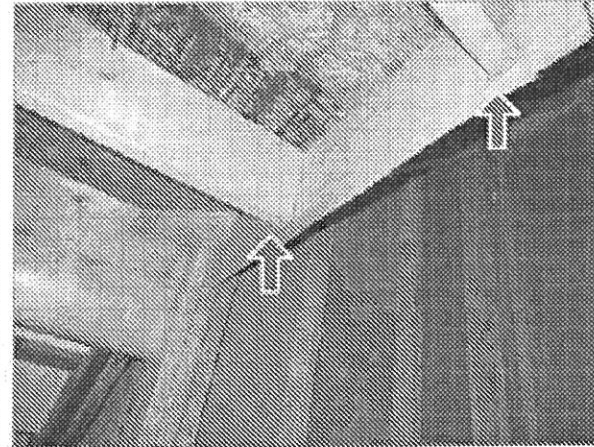
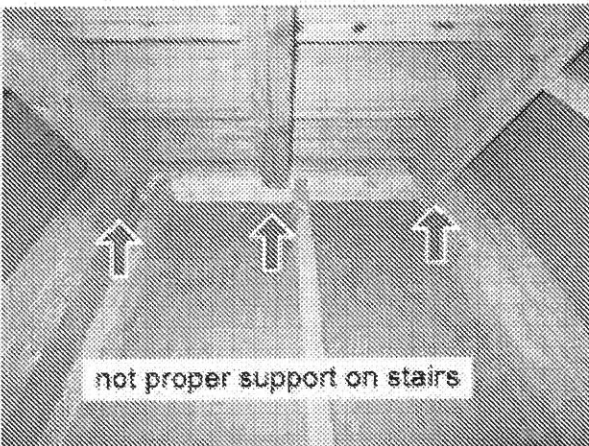
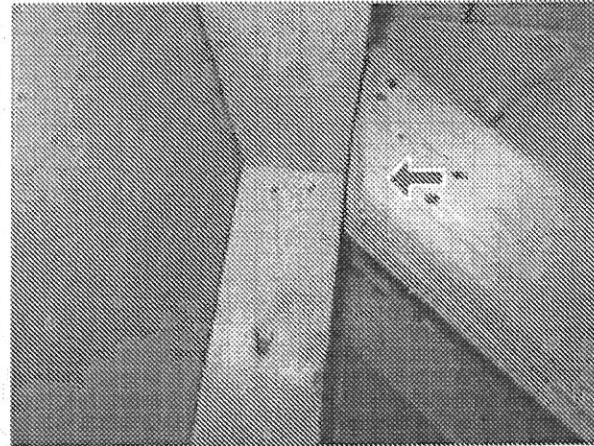
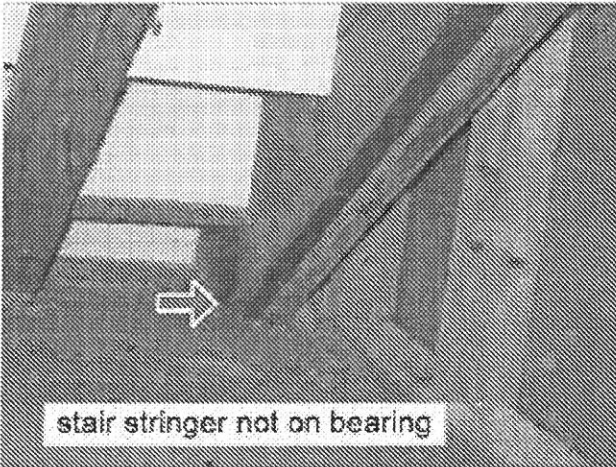
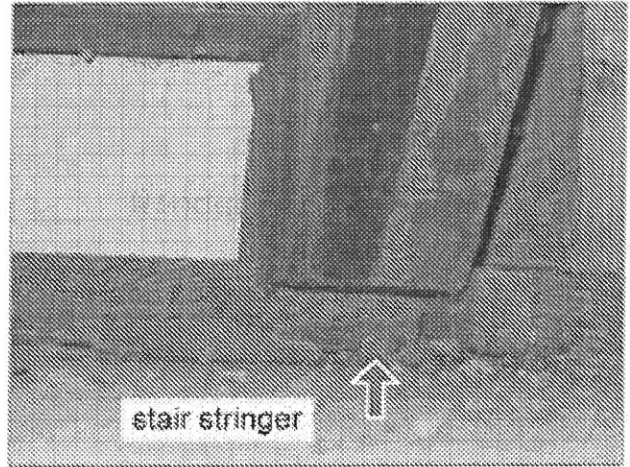
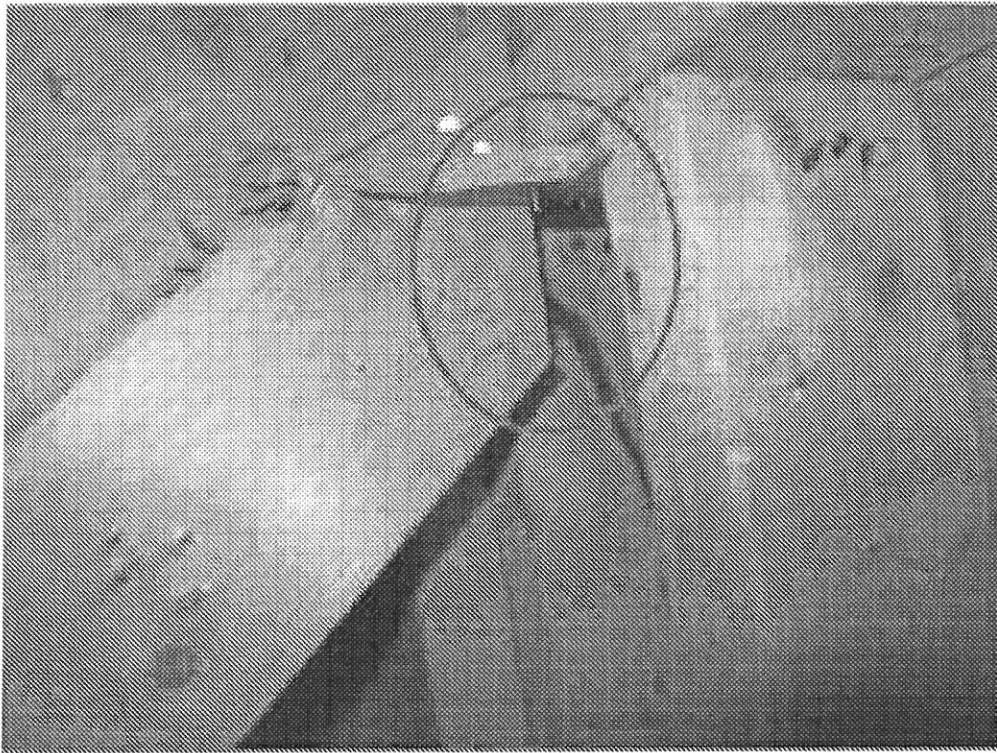
- **The basement steps were built or repaired in an unprofessional manner that renders them defective, including not having adequate support or hanger straps, and the stair stringer not resting on a bearing:**
