OFFICE OF SURFACE MINING

***Evaluation for Targe Energy dba Coal Valley, LLC
SMA Permit No. O-2005-10, NPDES WV1023721, and UIC 0284-00-033***

April 21, 2011

Harrison County, West Virginia

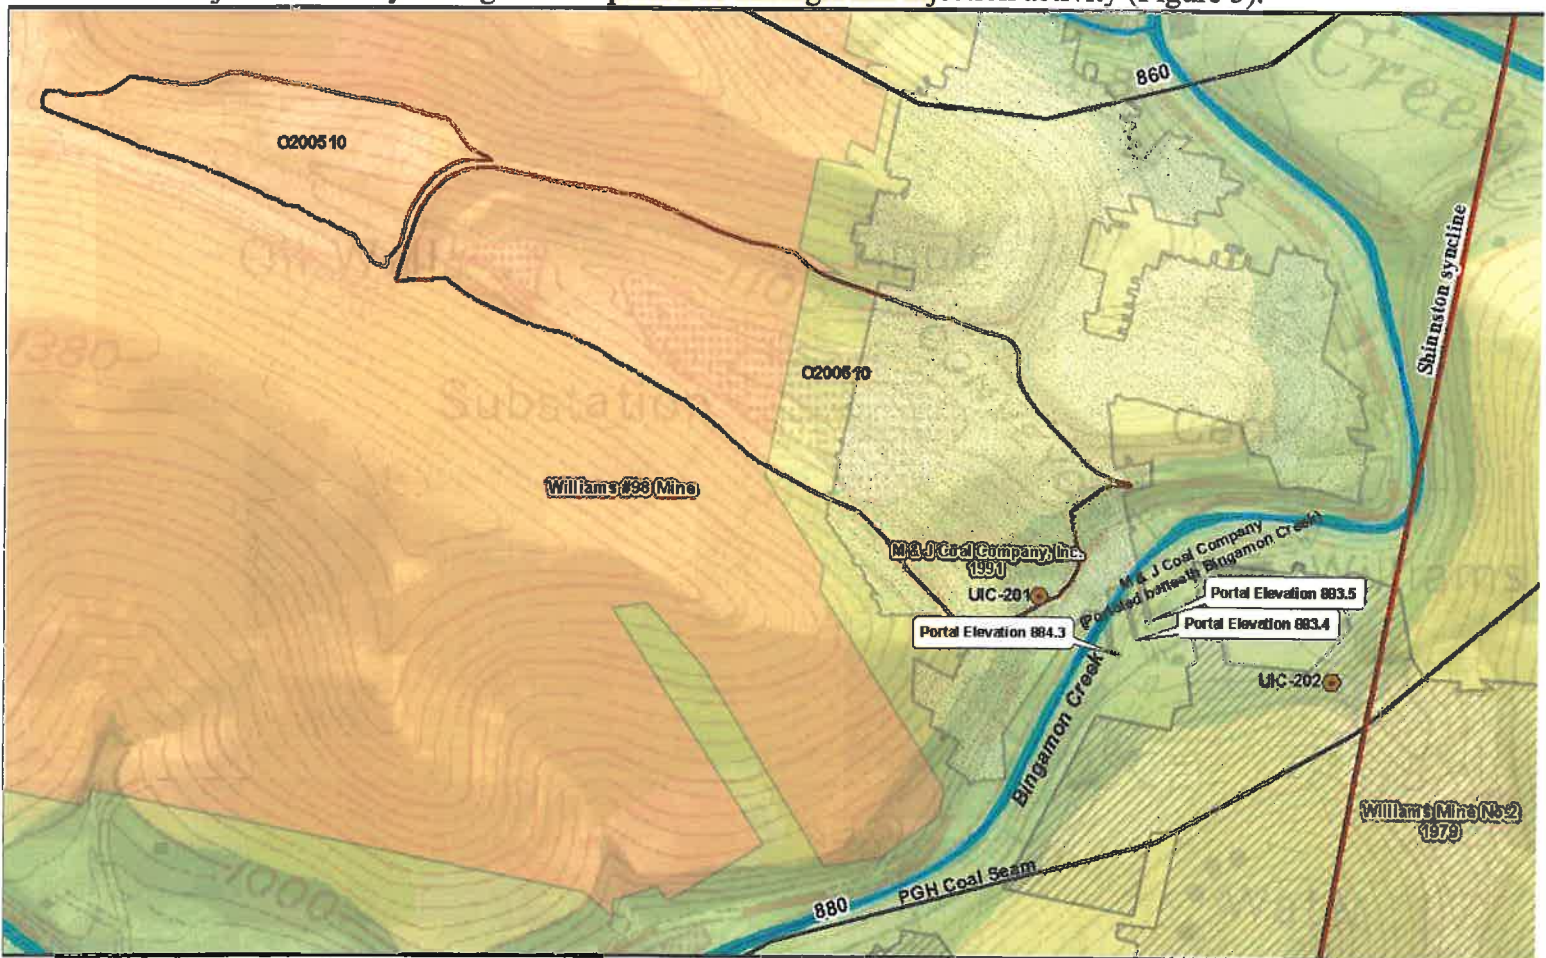
A post SMCRA underground mine (M & J Coal Company, Inc. Permit Number U-1037-86 is located adjacent to the Consol Williams #98 mine. Additionally, the M & J permit is located directly below the Williams No.2 Slurry Impoundment. The M & J permit allowed room and pillar and included second mining. The permit was final released on July 21, 1998. According to the UIC 201 permit it was drilled to a depth of approximately 40 feet and presumably isolated from the Williams #98 Consol deep mine. According to conditions in the UIC permit, the mine pool elevation for UIC 201 was to be maintained at a maximum elevation of 888 feet. This level is to be monitored at least monthly and maintained or reduced through pumping or by cessation of injection activity throughout the period of underground injection activity (Figure 5).

Figure 5. Location of Permit O-2005-10, Injection site UIC 201, M & J Coal mining and portal area with portal elevations.

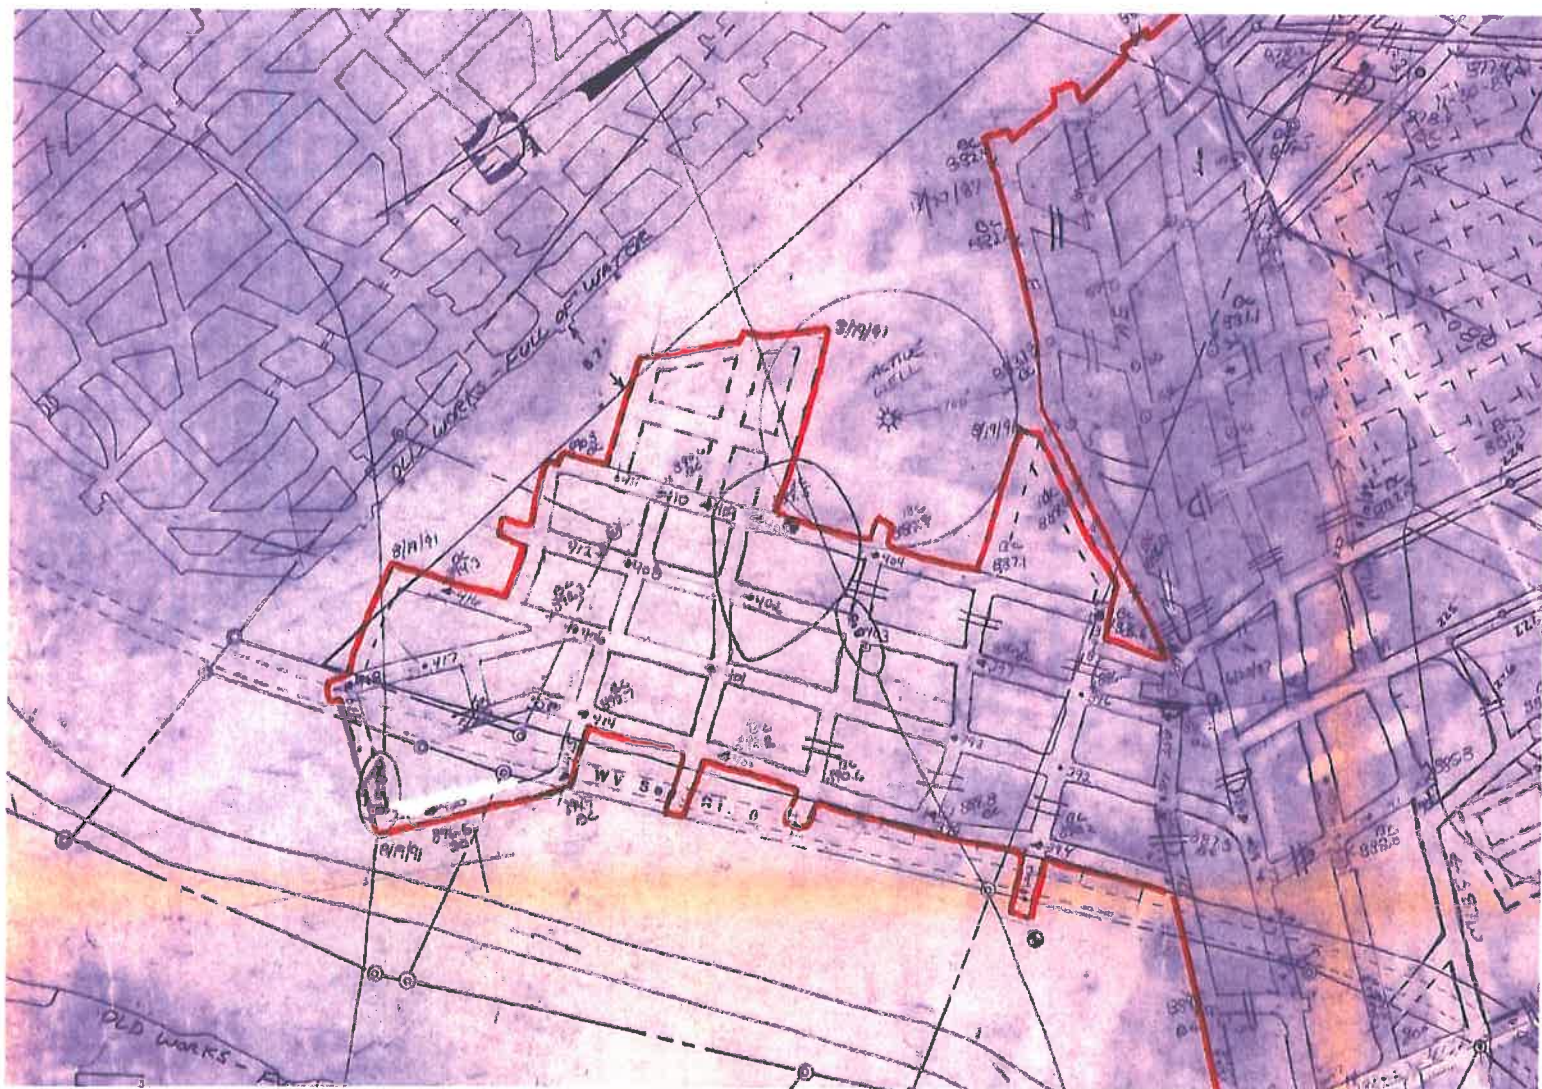
In addition to the M & J mine being inundated the adjacent historical Williams 98 Mine complex that contained a UIC borehole that originally received pumped discharge from the refuse impoundment is flooded as well. The flooded mine entries are recorded on historical underground mine maps obtained from WVGES (Figure 6). All water levels that were measured within the sampled boreholes had significant levels of water that was well above the targeted 888 ft. elevation in the UIC 201 borehole, the borehole that was drilled into the adjacent Williams #98 mine that was west of M & J, and the borehole that was sampled in Long Run. The adjacent M & J shafts were flooded to surface level as well. Coal Valley, LLC had proposed using the original borehole that was utilized by the slurry impoundment; however, the borehole that Coal Valley, LLC had re-drilled without a proper permit was inundated as well. It is not recommended that Coal Valley, LLC be allowed to use any additional UIC boreholes within the impoundment area since the underlying works are flooded and allowing impounded water within the refuse area. If Coal Valley, LLC were to be allowed to use an injection location within the refuse area the company would be required to obtain a valid UIC permit and report that the mine pool has void area that could receive the injected fluids as well as, permission from Consolidation Coal Company to inject within the Williams #98 mine pool. This mine pool is potentially being treated by Consol and may require co-cost for treatment.

Figure 6. Map for M & J Coal Company, NPDES permit renewal WV1002490 dated 10/20/97, indicating the Williams #98 old mining complex is flooded.

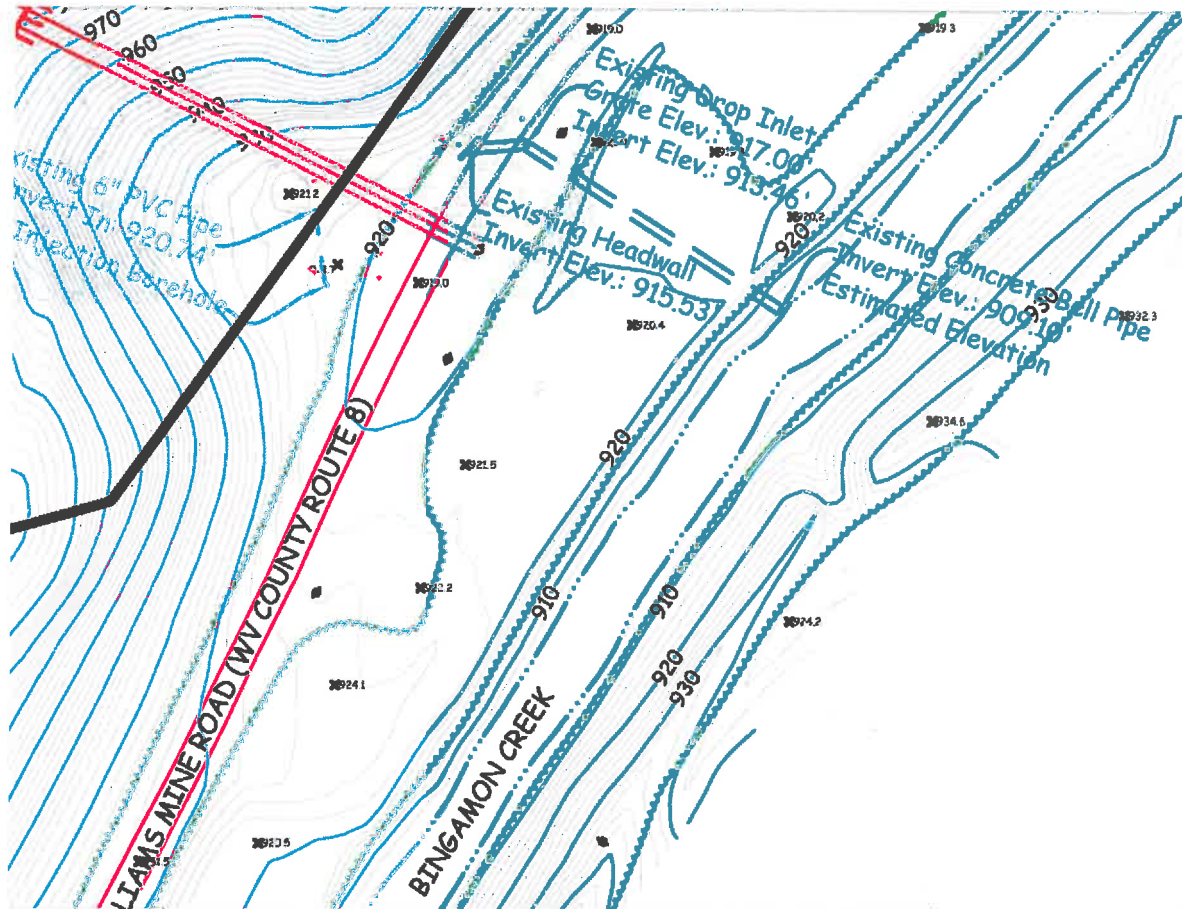
It was determined in the field review that the M & J mine is in fact not restricted and upwells to the surface as well as discharges into Bingamon Creek by entering an inverted drop inlet, (elevation 913.46) that crosses under County Route 8 and discharges through an existing inverted

concrete "Bell Pipe" at an elevation of 909.10 ft. This condition is causing the stream to be stained as a result of precipitates. Water samples were collected by WVDEP from the discharge to Bingamon Creek on March 8, 2011, and results are pending (Figure 7, 8, and 9).

Figure 7. Design from Coal Valley, LLC permit.

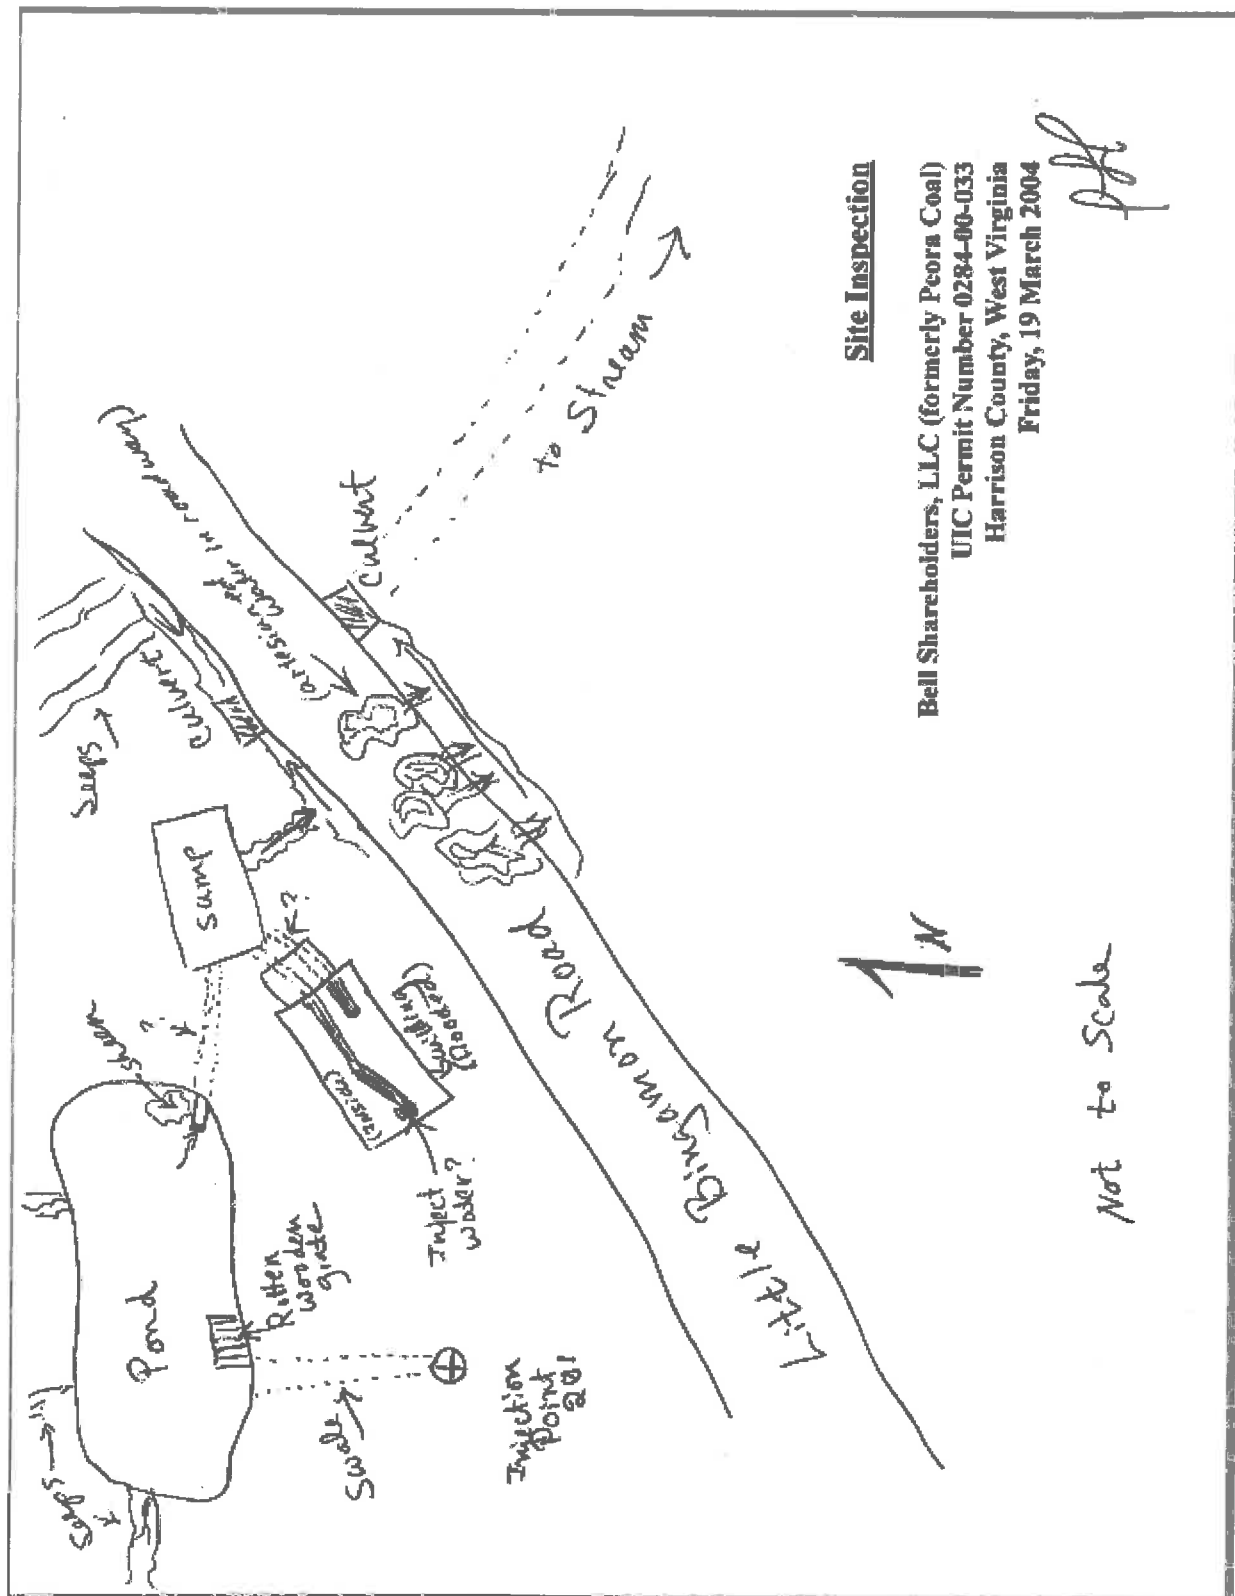
The historical mining by M & J Coal Company, Inc., Permit U-1037-86 where the injection site was installed has a history of seeps, upwelling, and subsidence. Photos from a site visit made on March 19, 2004, by WVDEP in response from a citizen complaint reveal the post mining damage to County Road 8. The subsidence fractures allowed for additional surface infiltration from storm events to infiltrate into an already flooded mine (Figures 13, 14 and 15).

Figure 15. Schematic of upwelling and seeps.

This is an excerpt of conclusions from the March 19, 2004, site visit (Figure 15).
